ROOF ASSESSMENT REPORT

CONLEY ELEMENTARY SCHOOL

NOVEMBER 08, 2010

WHITMAN HANSON REGIONAL SCHOOL DISTRICT

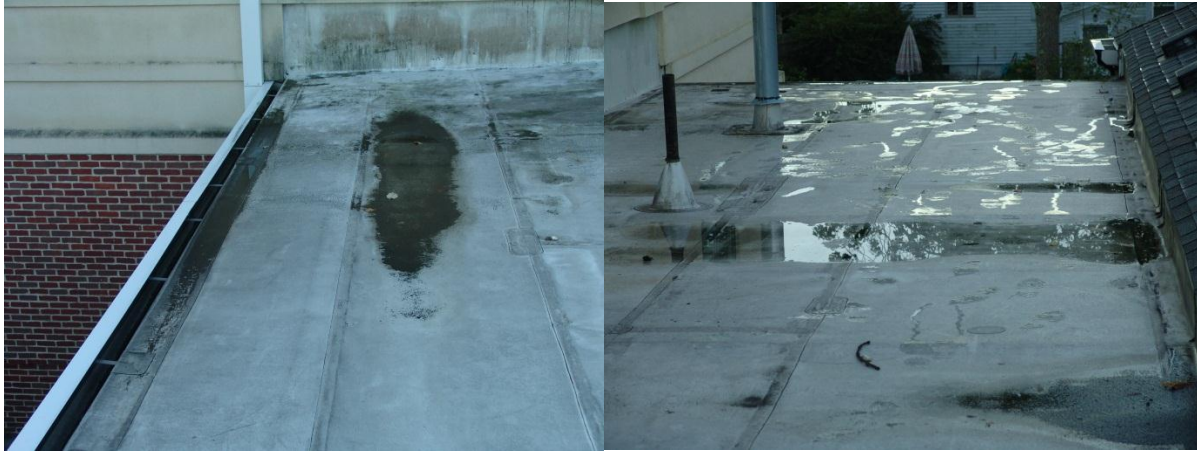
Observation No. 1

Minor ponding of water, low points, main PVC flat roof, coordinates M3 and N3.

A Remove debris and any organic growth, clean impacted roof areas (currently not reported as leaking).

Inspect problematic areas yearly; implement short term recommendations as necessary. Coordinate installation of crickets/tapered insulation (to drain water to external gutters) at time of future roof replacement.

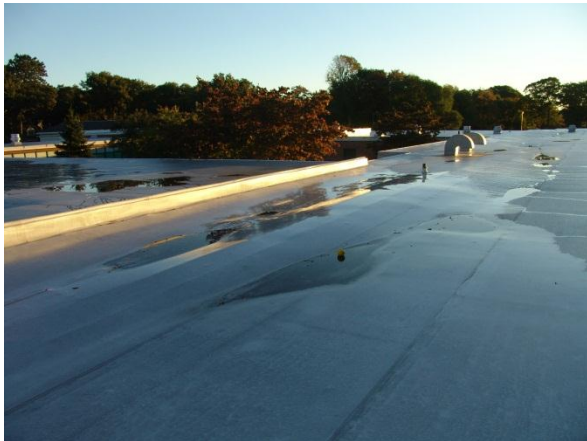
Observation No. 2

Ponding water, low points, main PVC flat roof, coordinates L5-L7.

Inspect area yearly; verify no leaks are evident below.

Inspect problematic areas yearly; implement short term recommendations as necessary. Coordinate

installation of crickets/tapered insulation (to drain water to roof drains) at time of future roof replacement.

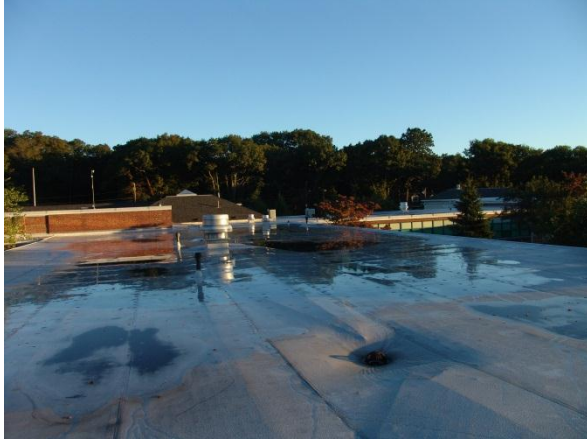
Observation No. 3

Ponding water, low points, main PVC flat roof, coordinates G6, G7-K6, K7.

Watch for future leaks at ceiling below (currently not reported as leaking).

Inspect problematic areas yearly; implement short term recommendations as necessary. Coordinate installation of crickets/tapered insulation (to drain water to roof drains) at time of future roof replacement.

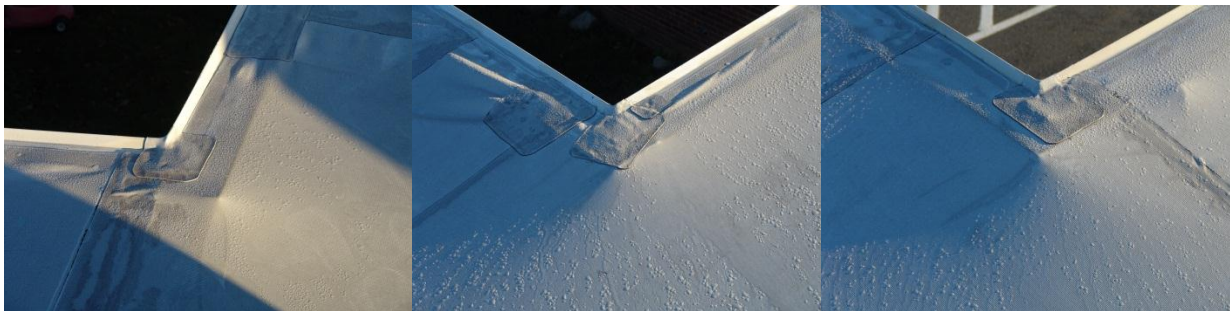
Observation No. 4

Poor transitions at perimeter corners, edge blocking protruding/stressing PVC membrane, typical at most inside corners, main PVC flat roof, coordinates, K8, K10, L14,K14,H14.

Inspect problematic areas yearly; watch for future leaks at ceilings below (currently not reported as leaking) limit foot traffic.

Coordinate installation of crickets/tapered insulation (to provide smooth, solid transitions and eliminate stress/puncture points) at time of future roof replacement.

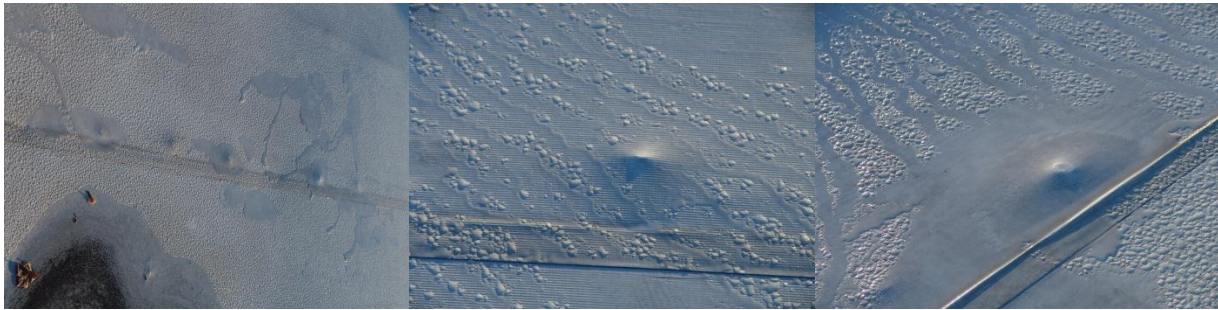
Observation No. 5

Protruding fastener heads, main PVC flat roof, coordinates L10, K13.

Inspect problematic areas yearly; watch for future leaks at ceilings below (currently not reported as leaking) limit foot traffic.

Remove protruding fasteners, replace with new fasteners/washers and assure proper tight/holding into deck/substrate below.

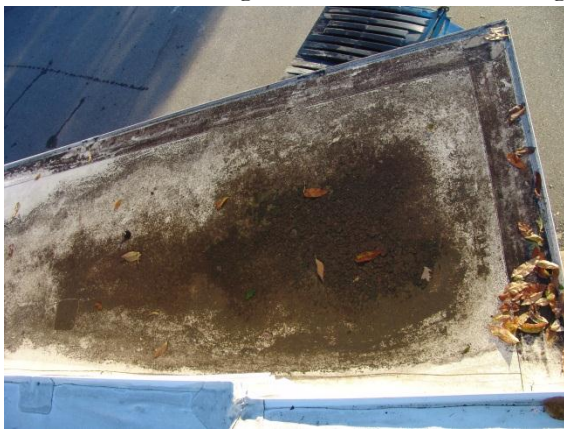
Observation No. 6

Debris and standing water, no roof drain or gutter system, lower PVC flat roof, coordinate G14.

Remove debris and standing water, clean roof, inspect area periodically; watch for future leaks at ceiling below (currently not reported as leaking).

Inspect areas yearly; implement short term recommendations as necessary. Install gutter and downspout. Coordinate installation of crickets/tapered insulation to drain water to new gutter at the time of future roof replacement.

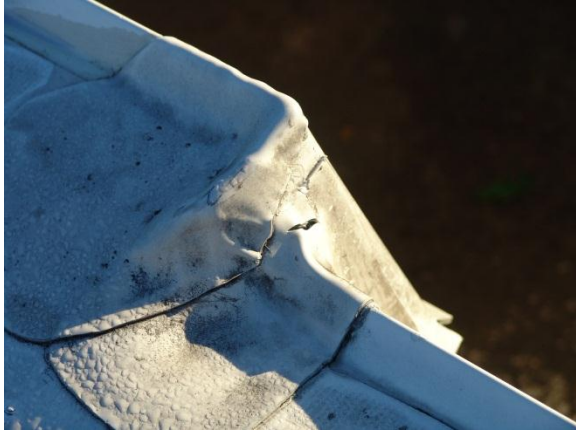
Observation No. 7

Crack at PVC corner flashing, main PVC flat roof, coordinate G14.

Clean and install compatible roofing cement/sealant.

Inspect area yearly; implement short term recommendations as necessary until roof replacement.

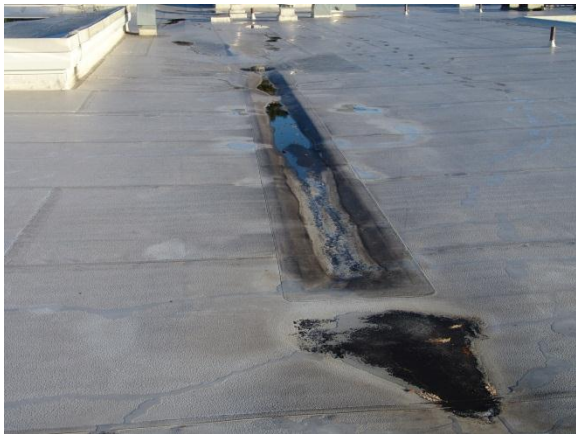
Observation No. 8

Ponding water, low points, main PVC flat roof, coordinates I12-K12.

Inspect area yearly; verify no leaks are evident below (currently not reported as leaking).

Inspect problematic areas yearly; implement short term recommendations as necessary. Coordinate installation/modification of crickets/tapered insulation (to drain water to roof drains) at time of future roof replacement.

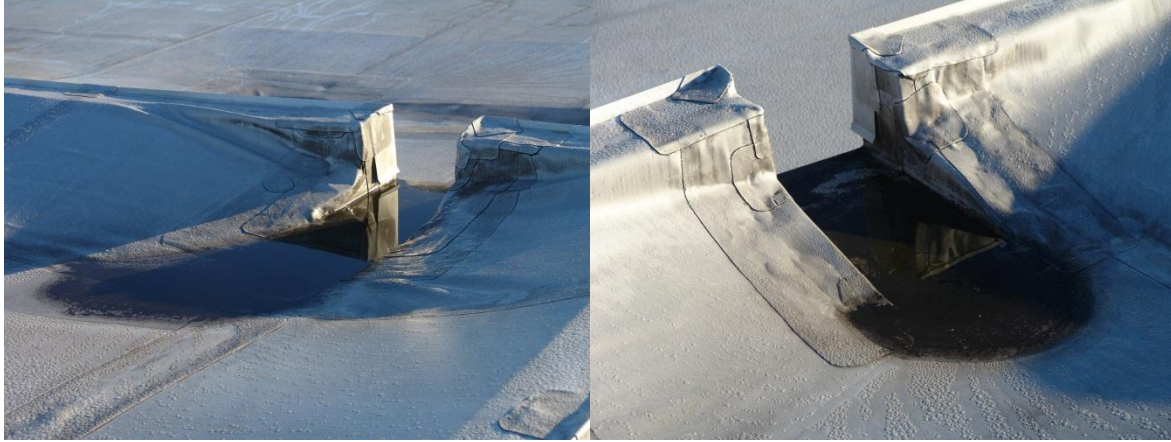
Observation No. 9

Water pockets at roof scuppers, upper PVC flat roof, coordinates H12, I12.

Inspect yearly for evidence of leaks below.

Coordinate installation of crickets/tapered insulation at roof scuppers to drain water off roof at time of future roof replacement.

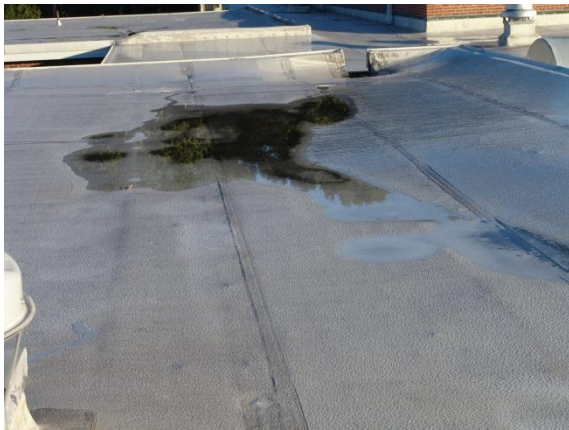
Observation No. 10

Ponding water, low point, upper PVC flat roof, coordinate H11.

Inspect yearly for evidence of leaks below.

Coordinate installation of crickets to drain water to scuppers at time of future roof replacement.

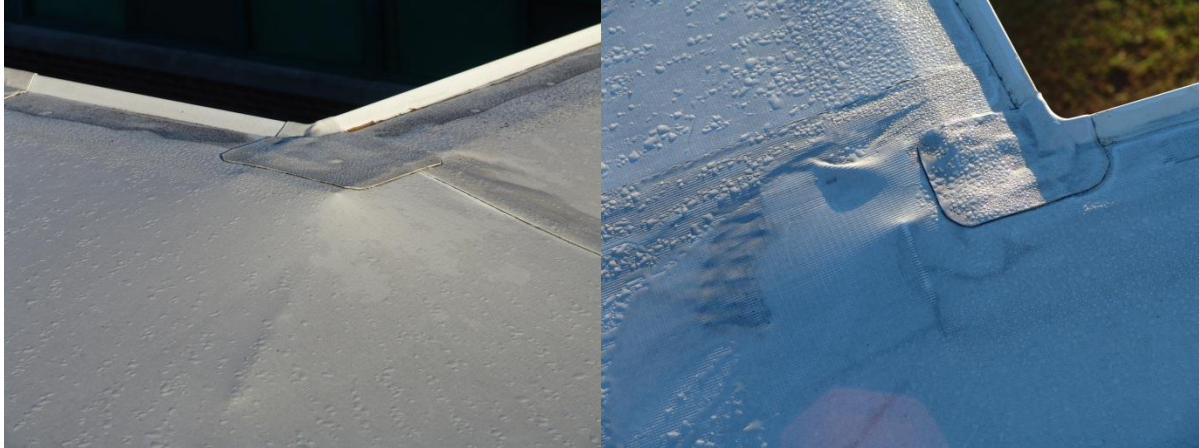
Observation No. 11

Poor transitions at perimeter corners, edge blocking protruding/stressing PVC membrane, typical at most inside corners, main PVC flat roof, coordinates, G11, H14.

Inspect yearly for evidence of leaks below.

Coordinate installation of crickets/tapered insulation (to provide smooth, solid transitions and eliminate stress/puncture points) at time of future roof replacement.

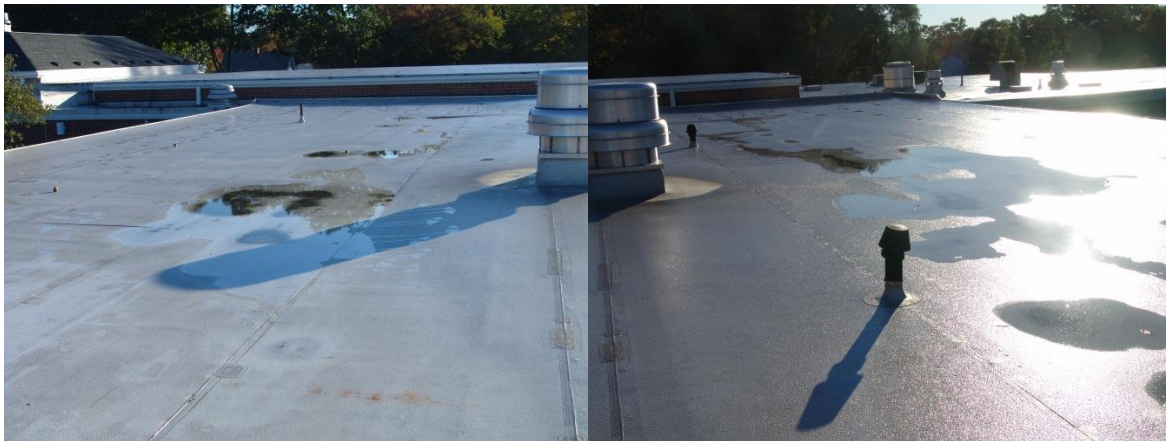
Observation No. 12

Ponding water, low points main PVC flat roof, coordinates D9, E10.

Inspect yearly for evidence of leaks below.

Coordinate installation of crickets/tapered insulation to drain water to roof drains at the time of future roof replacement.

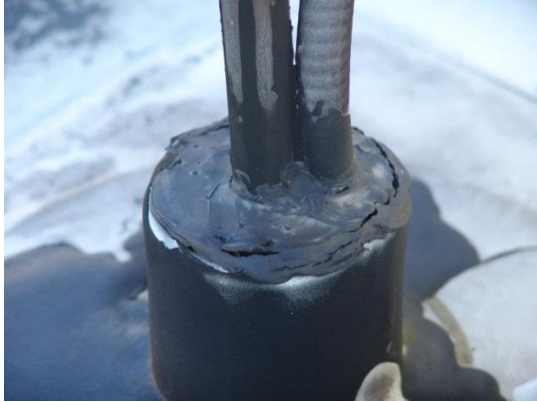
Observation No. 13

Cracks at pitch pocket, main PVC flat, coordinate D8.

Apply compatible roofing cement/sealant.

Inspect yearly, implement short term recommendations until roof replacement, replace pitch pocket at that time.

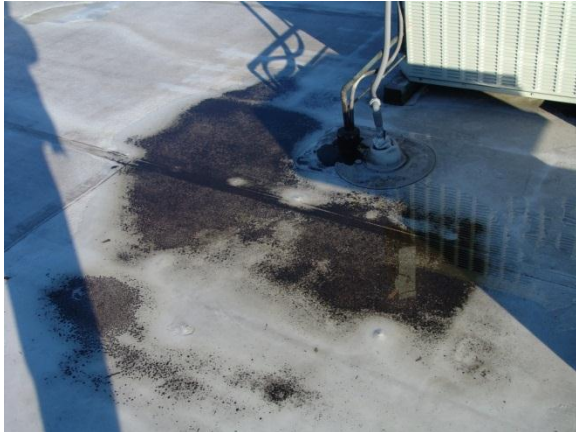
Observation No. 14

Minor ponding water, and protruding fasteners, main PVC flat roof, coordinate D8.

Inspect yearly for evidence of leaks below and/or material deterioration, limit foot traffic.

Remove protruding fasteners, replace with new fasteners/washers and assure proper tight/holding into deck/substrate below. Coordinate installation/modification of crickets/tapered insulation (to drain water to roof drains) at time of future roof replacement.

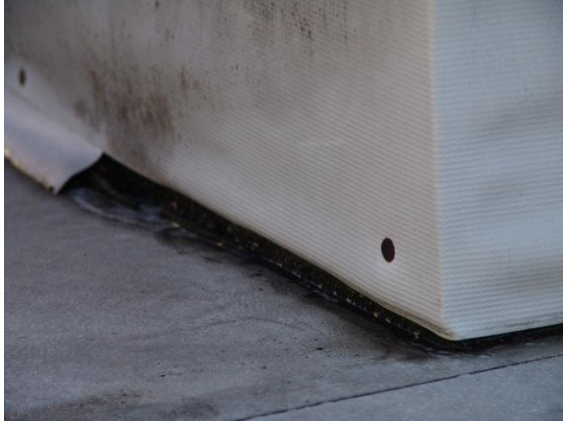
Observation No. 15

Rotting plywood dog house not flashed to roof, main PVC flat roof, coordinate G3.

Inspect yearly.

Remove and rebuild/fasten enclosure onto PT curbing, properly flash to main roof membrane at the time of future roof replacement.

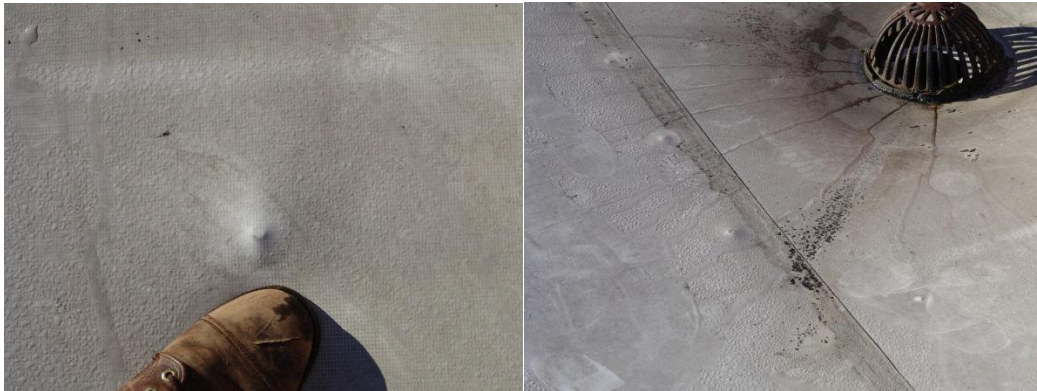
Observation No. 16

Protruding fastener head at roof drain, main PVC flat roof, coordinate F6.

Inspect problematic areas yearly; watch for future leaks at ceilings below (currently not reported as leaking) limit foot traffic.

Remove protruding fasteners, replace with new fasteners/washers and assure proper tight/holding into deck/substrate below.

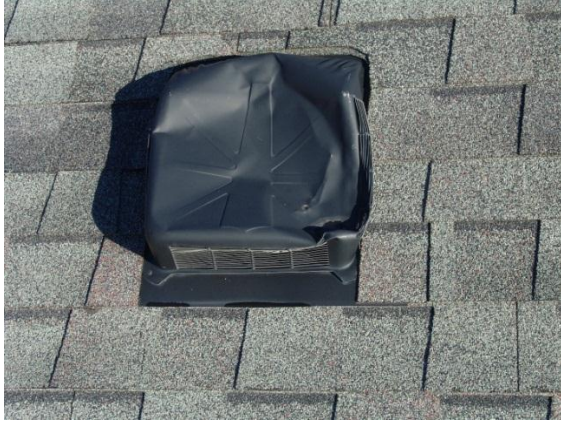
Observation No. 17

Crushed roof vents (3), sloped asphalt shingle roof, D6-D7.

Replace crushed vents.

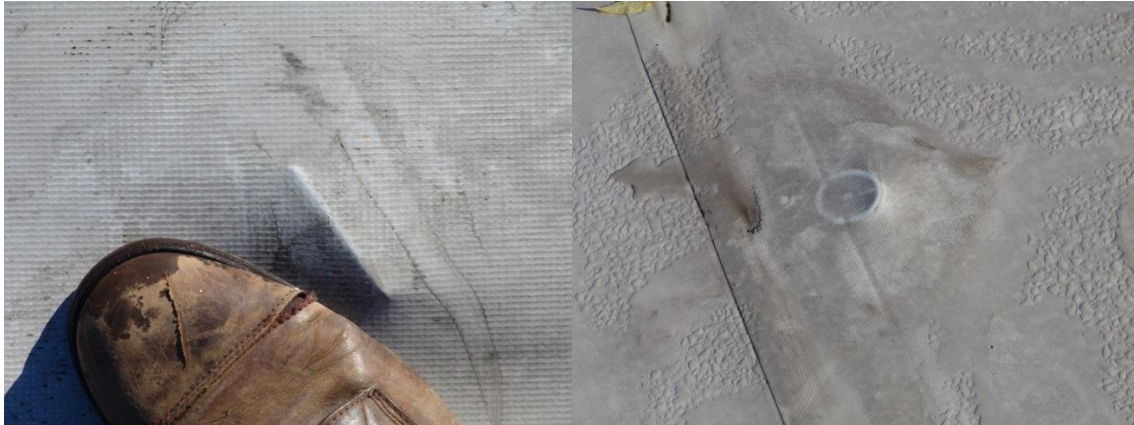
Observation No. 18

Protruding fastener heads, upper PVC flat roof, coordinates H2, I2.

Inspect problematic areas yearly; watch for future leaks at ceilings below (currently not reported as leaking) limit foot traffic.

Remove protruding fasteners, replace with new fasteners/washers and assure proper tight/holding into deck/substrate below.

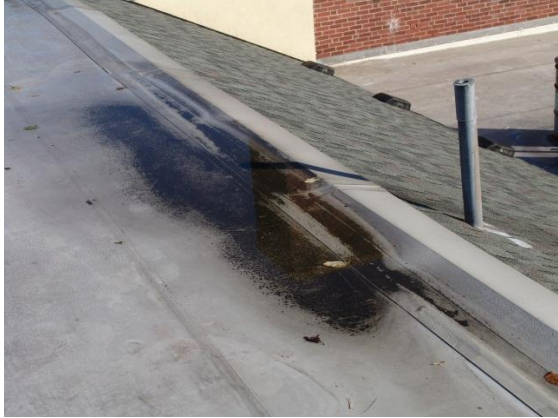
Observation No. 19

Ponding water, high PVC flat roof, coordinate G2. Leaks in adjacent Art Room below have been reported. Transition of flat to sloped roof with integral vent is likely to allow wind driven water in through vent. Similar ponding water condition occurs at coordinates J2 and N2, G1, I1, J1 and L1 (no leaks reported).

Install backer-rod and sealant to block transition vent extend ten feet beyond area of ponding water.

Remove/modify alum.as required to provide scupper relief system at the center of each ponding area. Alternately, remove alum. Transition vent, install new, lower transition to sloped roof area and install box/roof vents (to vent top area of shingled roof).

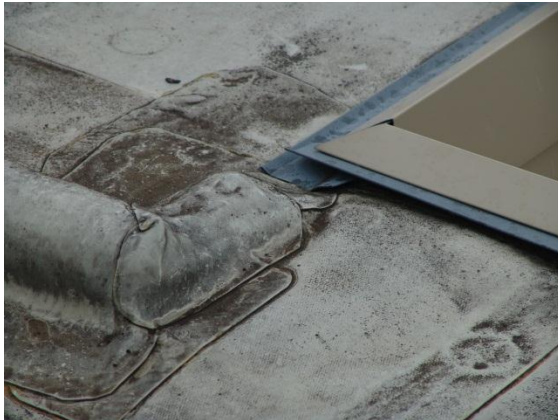
Observation No. 20

Lifted gravel stop spring clip, high PVC flat roof, coordinate G12.

Inspect yearly for evidence of leaks below.

Coordinate proper installation of gravel stop, spring clip and PVC roof edge termination at the time of future roof replacement. Refer to manufacturer's standard/recommended installation details.

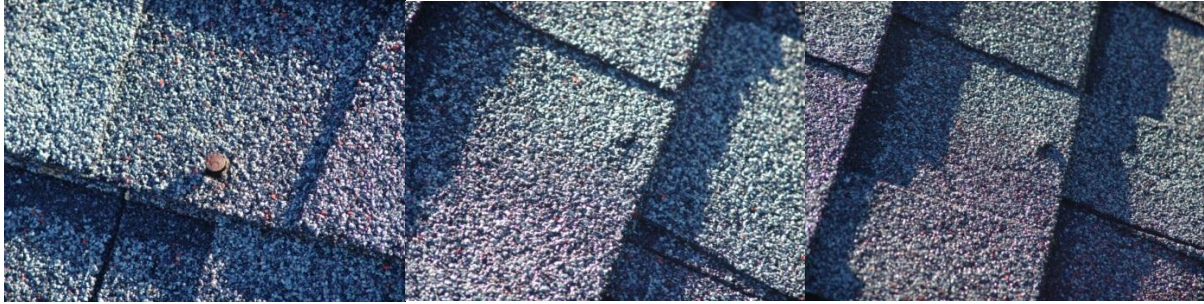
Observation No. 21

Protruding fasteners at sloped asphalt shingle roof area, coordinate O4.

Remove protruding fasteners, apply compatible roofing cement.

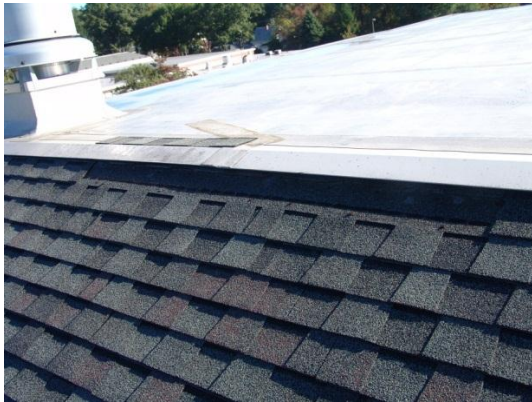
Observation No. 22

Torn/missing roof shingles (six feet), at sloped asphalt shingle roof area, coordinate O4.

Remove protruding fasteners, install new shingles to match existing.

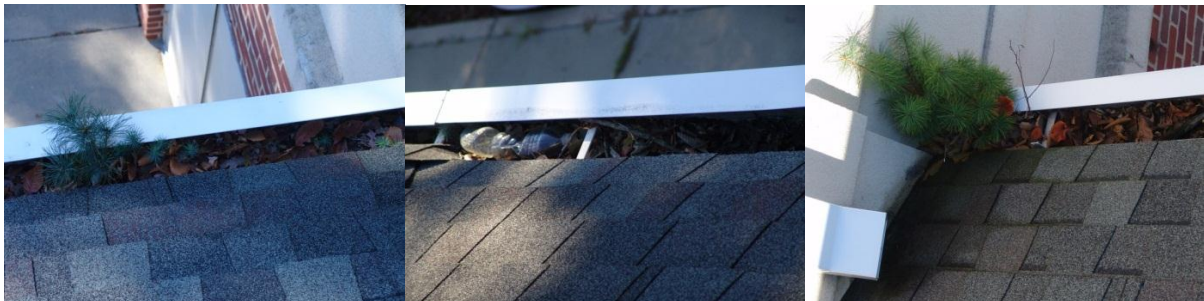
Observation No. 23

Debris and organic matter in gutter at lower sloped asphalt shingle roof, coordinates N6-O6.

Remove debris and clean gutter.

Inspect yearly; implement short term recommendations as needed.

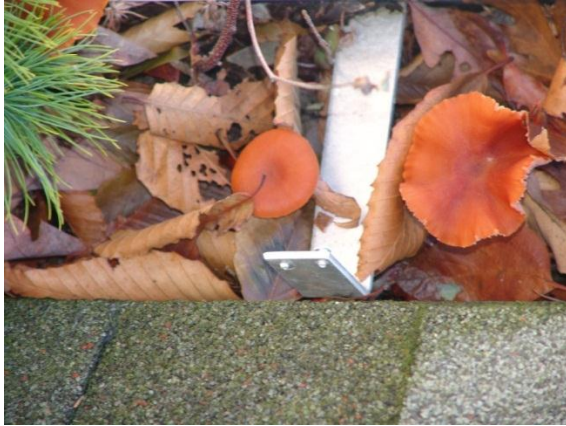
Observation No. 24

Detached gutter bracket at lower sloped asphalt shingle roof, coordinate N6.

Remove debris, and fasten bracket.

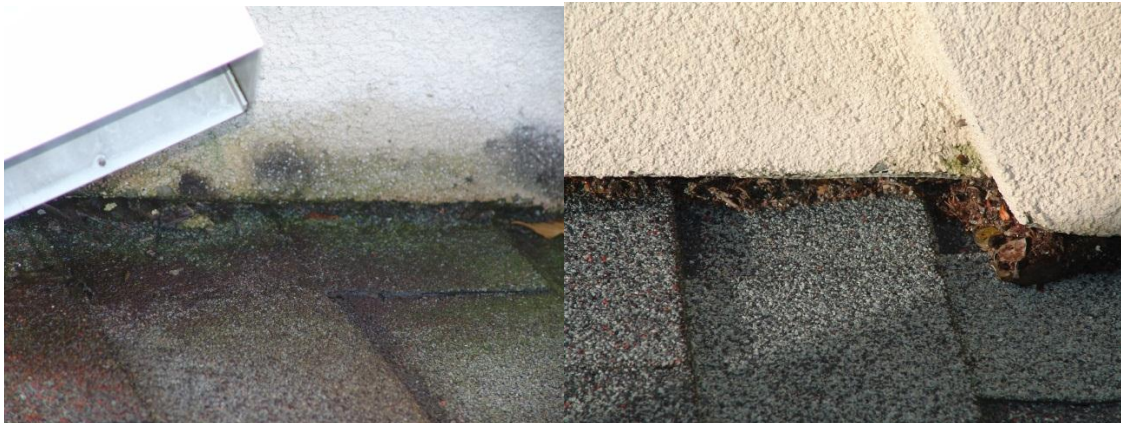
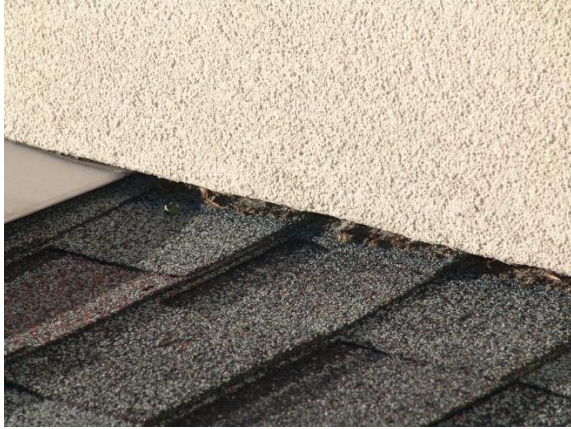
Observation No. 25

Poor roof-to-wall transition, EIFS too close to shingle roof. Organic matter build-up, deteriorating EIFS siding at lower sloped asphalt shingle roof, coordinate N6.

Remove debris and clean shingles/siding; install backer-rod and compatible sealant.

Cut back EIFS a minimum of 8" above roof surface, patch EIFS, install metal roof-to-wall flashing with reglet or termination bar set in water-cut-off-mastic.

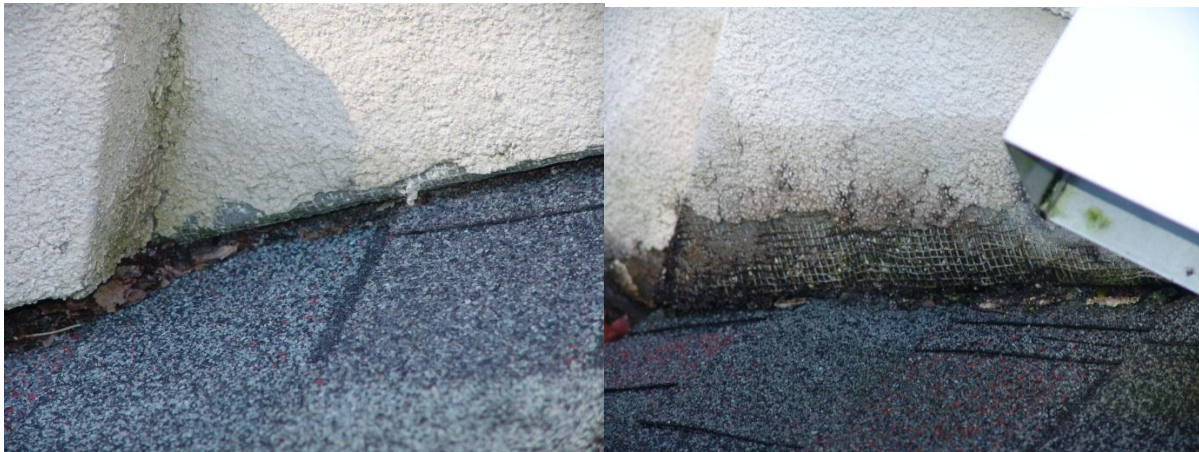
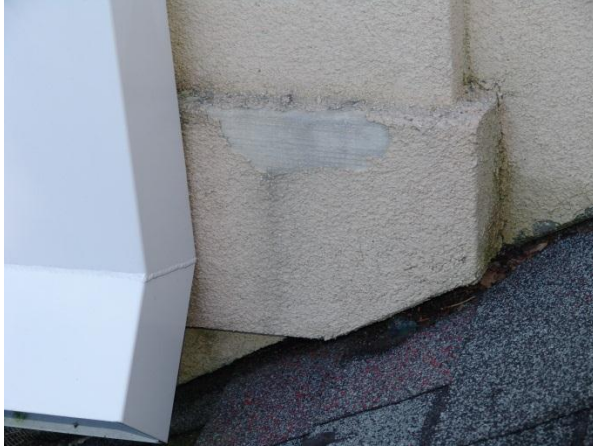
Observation No. 26

Poor roof-to-wall transition, EIFS too close to shingle roof. Organic matter build-up, deteriorating EIFS siding at lower sloped asphalt shingle roof, coordinate P6.

Remove debris and clean shingles and siding. Cut back EIFS a minimum of 8" above roof surface, patch EIFS, install metal roof-to-wall flashing with reglet or termination bar set in water-cut-off-mastic. Install backer-rod and compatible sealant.
