# **ROOF ASSESSMENT REPORT**

## **HANSON MIDDLE SCHOOL**

**NOVEMBER 08, 2010**

**WHITMAN HANSON REGIONAL SCHOOL DISTRICT**

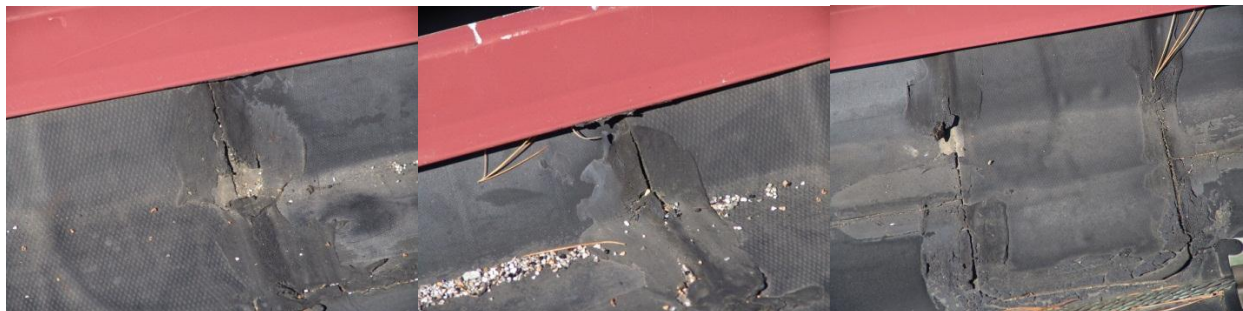
## Observation No. 1

Deteriorated lap sealant, main EPDM flat roof, coordinates D10, D11, C7. Typical condition throughout.

Remove old sealant, clean, apply compatible roofing cement/sealant.

Install appropriate EPDM patch.

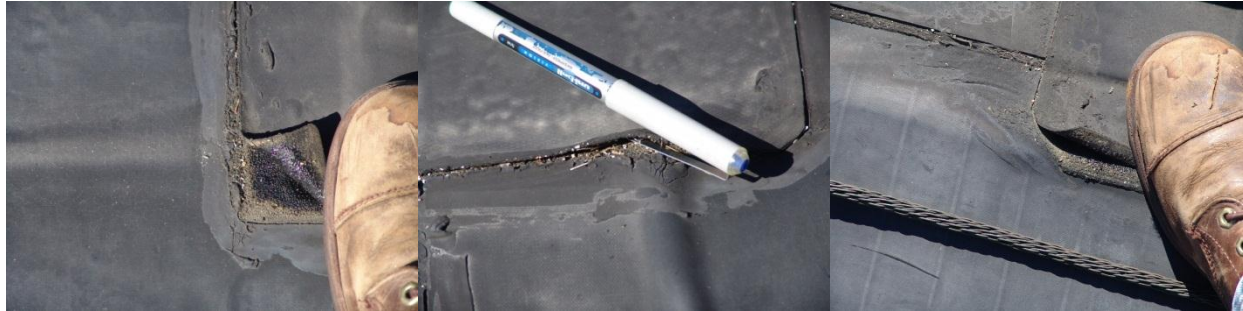
### **Observation No. 2**

Delaminating seams at lap splices and flashing corners, main EPDM flat roof, coordinates D12, D11, C7.

Remove old sealant, clean, apply compatible roofing cement/sealant.

Install appropriate EPDM patch

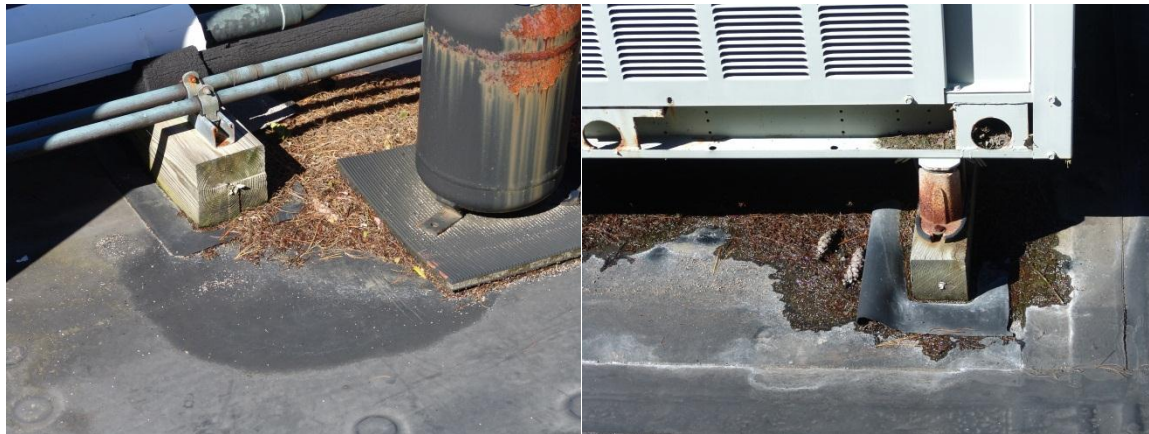
### **Observation No. 3**

Debris and organic growth at mechanical unit, main EPDM flat roof, coordinate E11. Leaks reported below.

Clean debris, inspect curb flashings, penetrations, etc. patch and repair.

Remove and install new curbing/supports and associated at the time of future roof replacement.

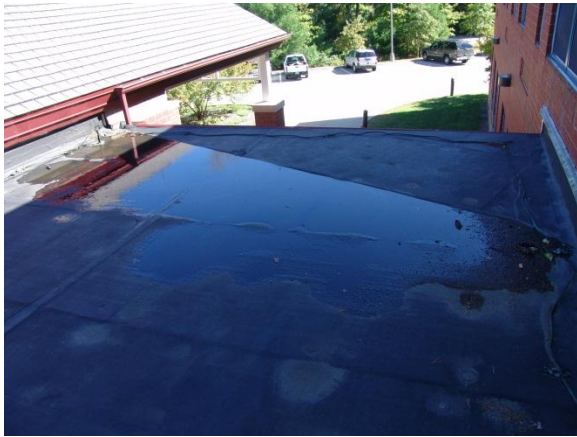
**Observation No. 4**

Ponding water, main EPDM flat roof, coordinate G5.

Inspect yearly for evidence of leaks below.

Coordinate modification of tapered insulation/protection board to drain water to external roof scupper at the time of future roof replacement.

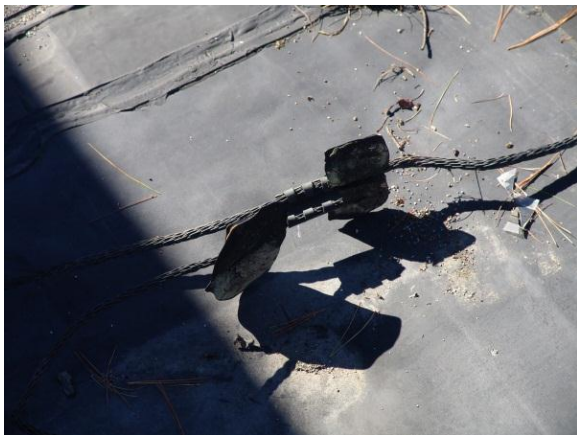
**Observation No. 5**

Detached fasteners at lightning prtotection system, main EPDM flat roof, coordinate D6.

Clean and re-fasten with compatible roofing cement/sealant, inspect yearly.

Indicative of aging roofing systems, implement above recommendation.

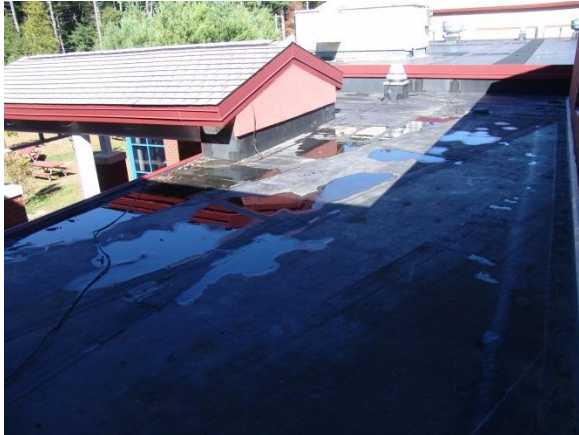
**Observation No. 6**

Ponding water, main EPDM flat roof, coordinates D5-D6. Leaks reported in adjacent areas below,

recently repaired.

Inspect yearly for evidence of leaks below. Investigate alternate, adjacent sources- louvers, windows and masonry wall construction.

Coordinate modification of tapered insulation/protection board to drain water to external roof scupper at the time of future roof replacement.

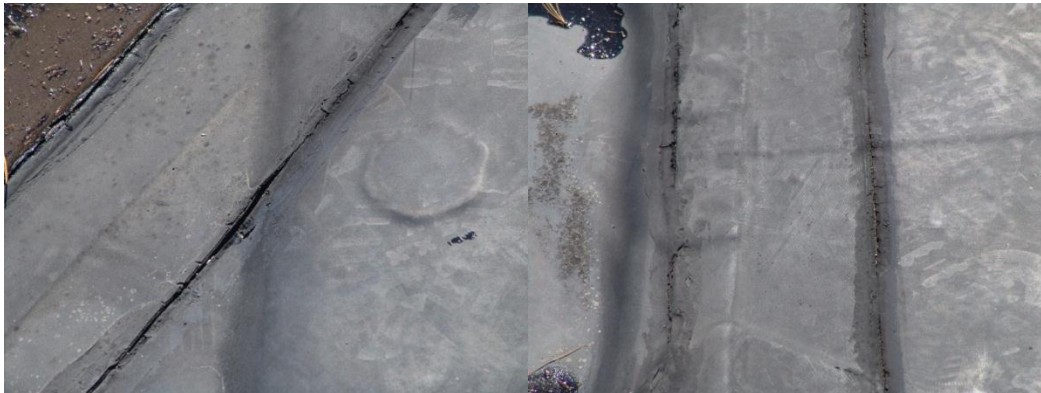
### **Observation No. 7**

Open seam at lap splice, main EPDM flat roof, coordinates E7, B8.

Remove old sealant, clean, apply compatible roofing cement/sealant.

Install appropriate EPDM patch.

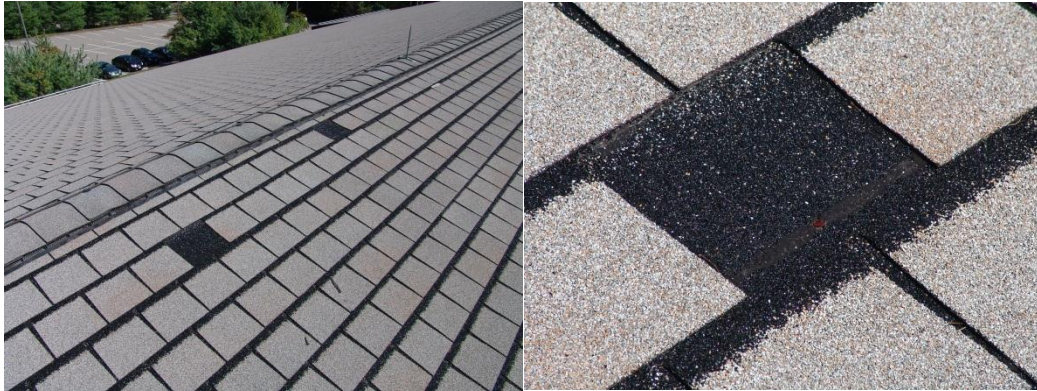
### **Observation No. 8**

Missing shingle tabs, upper sloped asphalt shingle roof, coordinate B13. Typical of eight locations,

C13, E13, F14, F15.

Replace damaged shingles.

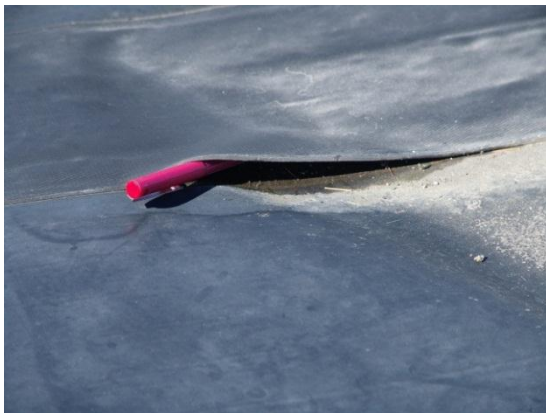
**Observation No. 9**

Delaminating seams at lap splices, upper EPDM flat roof, coordinate F12.

Remove old sealant, clean, apply compatible roofing cement/sealant.

Install appropriate EPDM patch.

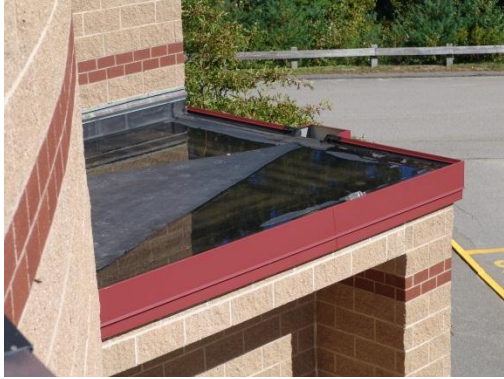
**Observation No. 10**

Ponding water, low flat EPDM roof, coordinate I13.

Inspect yearly for evidence of leaks below.

Coordinate modification of tapered insulation/protection board to drain water to external roof scupper at the time of future roof replacement.

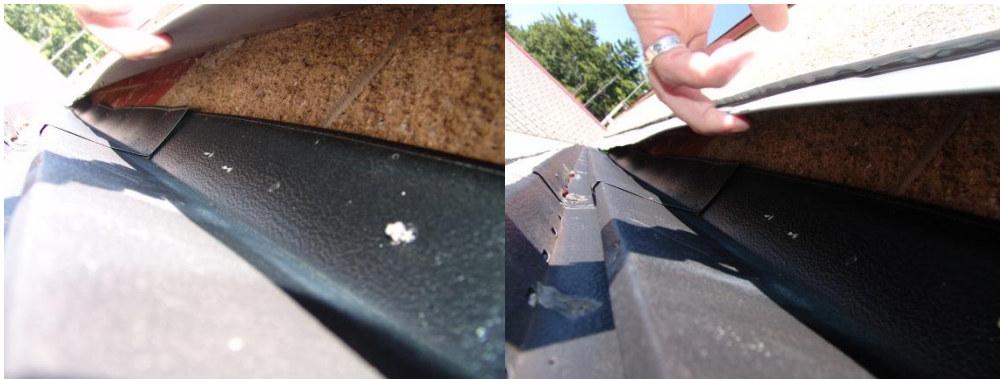
**Observation No. 11**

Loose roof-to-wall LCC counter flashing, coordinates F12-H12.

Inspect yearly for evidence of leaks below.

Coordinate modification fastening/adhering flashing to wall – set in roofing cement/water-cut-off mastic under constant pressure at the time of future roof replacement.

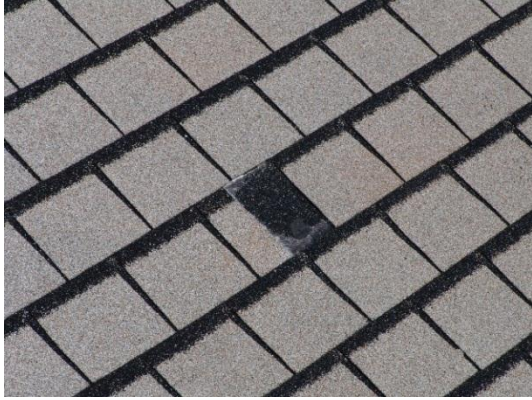
**Observation No. 12**

Missing shingle tabs, lower sloped asphalt shingle roof, coordinate G8.

Replace damaged shingles.

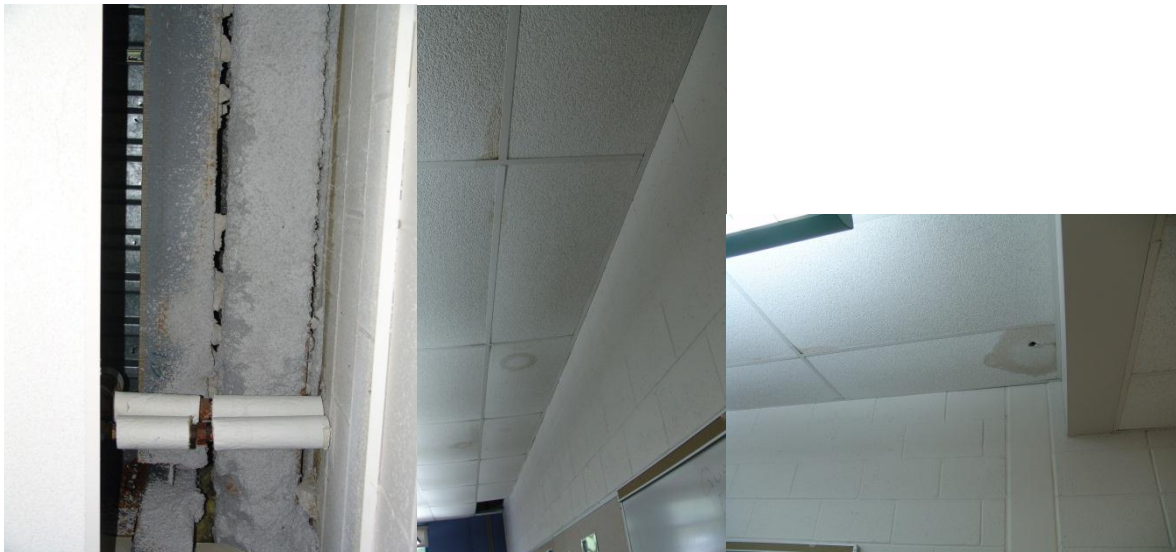
**Observation No. 13**

Leaks at classroom ceiling below expansion joint/roof to wall transition above, under main EPDM roof coordinates D12-E12.

Remove and replace EPDM membrane covering expansion joint and run up adjacent wall.

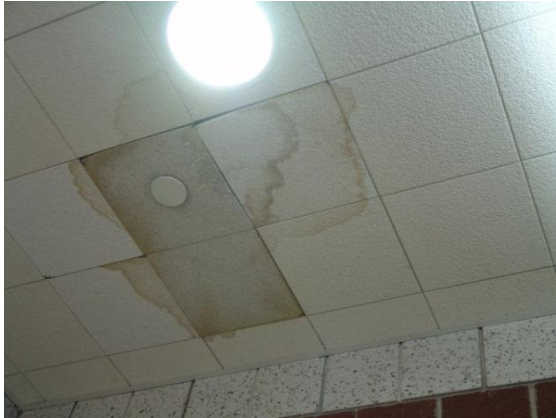
**Observation No. 14**

Leaks at corridor ceiling below expansion joint/roof to wall transition above, under main EPDM roof coordinates F11-F12.

Refer to Observation #3 for likely source of water and recommendations.

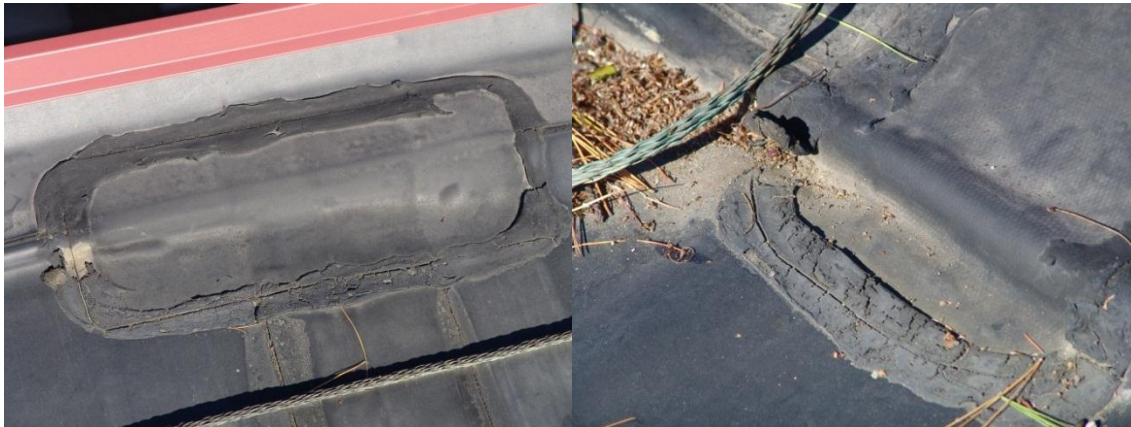
**Observation No. 15**

Failing patches and seam sealant, high EPDM flat roof, coordinate G4, F4.

Clean debris and sealant; install compatible seam sealant.

Repair with EPDM patch. Inspect all sealant, seam and patch conditions as part of ongoing maintenance at regular intervals.

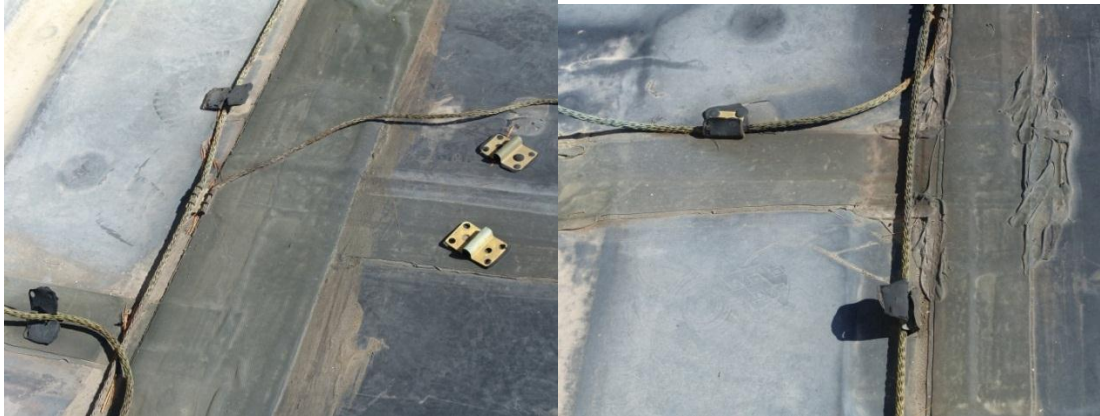
**Observation No. 16**

Detached fasteners at lightning prtotection system, main EPDM flat roof, coordinate D6.

Clean and re-fasten with compatible roofing cement/sealant, inspect yearly.

Indicative of aging roofing systems, implement above recommendation.

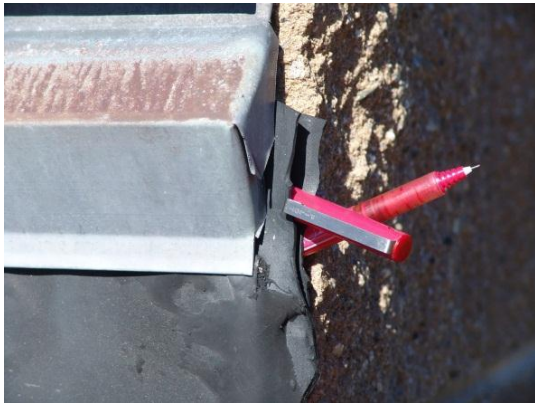
**Observation No. 17**

Open seams at roof-to-wall flashing/termination bar, high EPDM flat roof, coordinate A3.

Seal/set in compatible sealant.

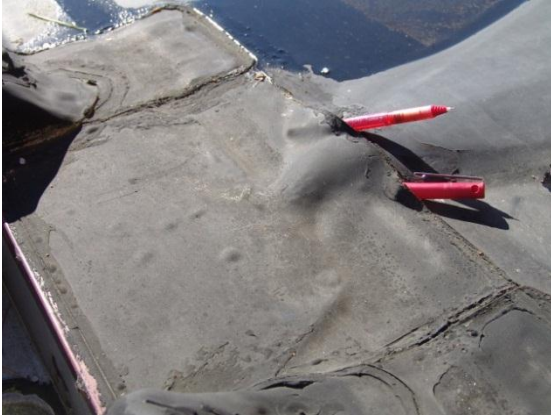
**Observation No. 19**

Failing patches and seam sealant, high EPDM flat roof, coordinate A2.

Clean debris and sealant; install compatible seam sealant.

Repair with EPDM patch. Inspect all sealant, seam and patch conditions as part of ongoing maintenance at regular intervals.

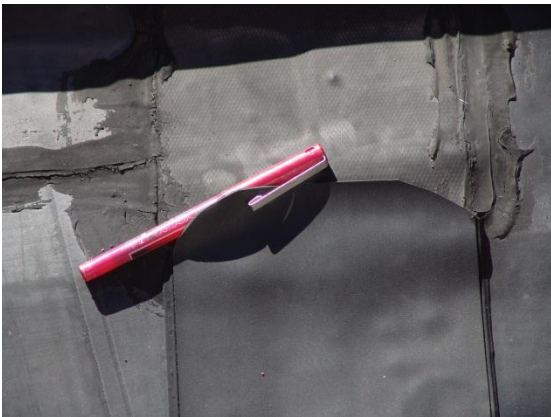
**Observation No. 20**

Lifted EPDM patch, low EPDM flat roof, coordinate D1.

Clean debris and sealant; set in compatible seam sealant.

Repair with EPDM patch.
