ROOF ASSESSMENT REPORT

INDIAN HEAD ELEMENTARY SCHOOL

NOVEMBER 08, 2010

WHITMAN HANSON REGIONAL SCHOOL DISTRICT

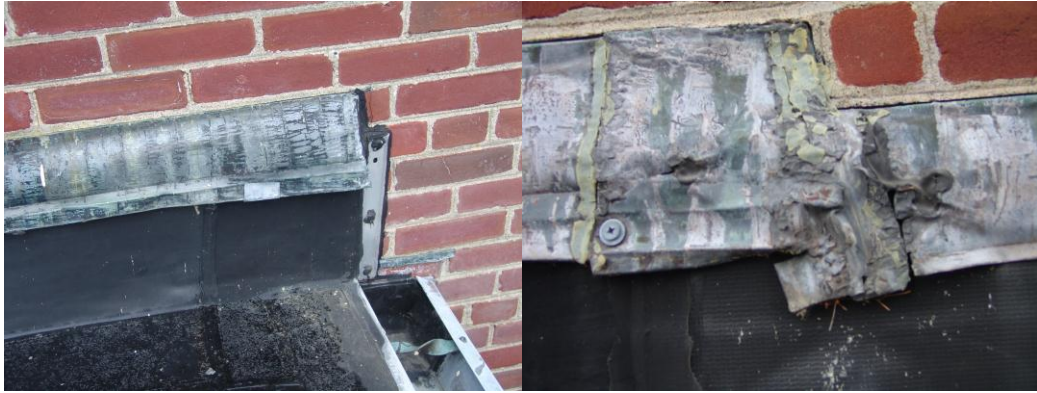
Observation No. 1

Copper counter flashing in fair to poor condition, no leaks reported, upper EPDM flat roof,

coordinate E5, , intermediate EPDM flat roof, coordinate C4. Typical condition.

Review periodically for evidence of leaks below.

Inventory locations and consider systematic replacement during future roof replacement projects.

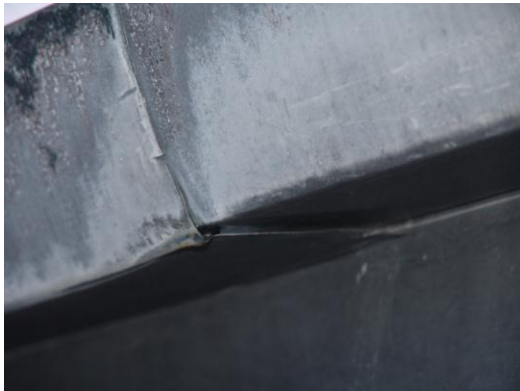
Observation No. 2

Open gutter seam, upper EPDM flat roof, coordinate F6.

Apply gutter seal at open seams.

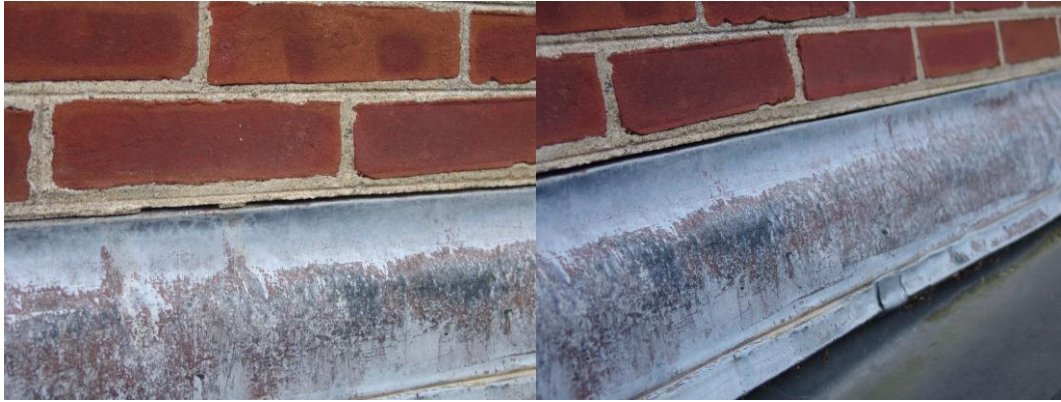
Observation No. 3

Open seams at counter flashing to masonry wall juncture, no leaks reported, intermediate EPDM flat roof, coordinate G5. Typical through-out.

Rake/clean joint, apply compatible sealant.

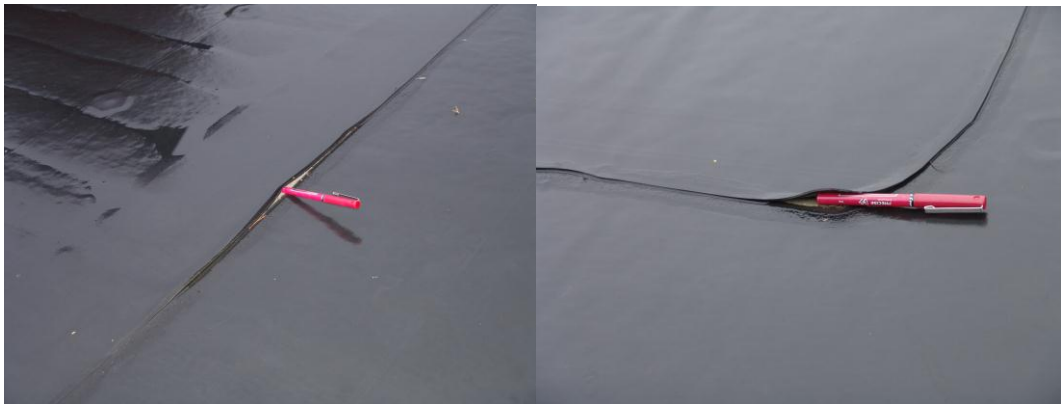
Observation No. 4

Open seams at lap splices, no leaks reported, approx. 70 LF +/-, intermediate EPDM flat roof, coordinate F7.

Clean; apply compatible roofing cement/sealant.

Inspect problematic areas yearly for evidence of leaks. Apply EPDM patch.

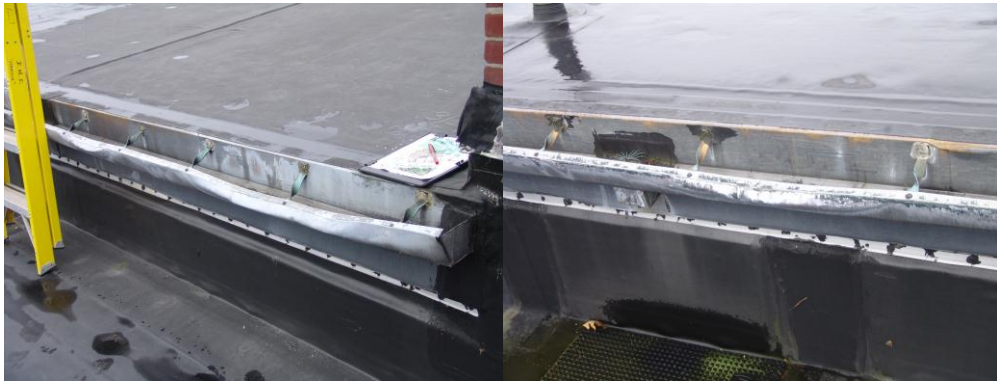
Observation No. 5

Bent/damaged gutter profile, 15 LF +/-, intermediate EPDM flat roof, coordinate D5,D6.

Check bracket fastener seal, watch for leaks.

Repair or replace damaged gutter sections, prohibit use as a ladder rung.

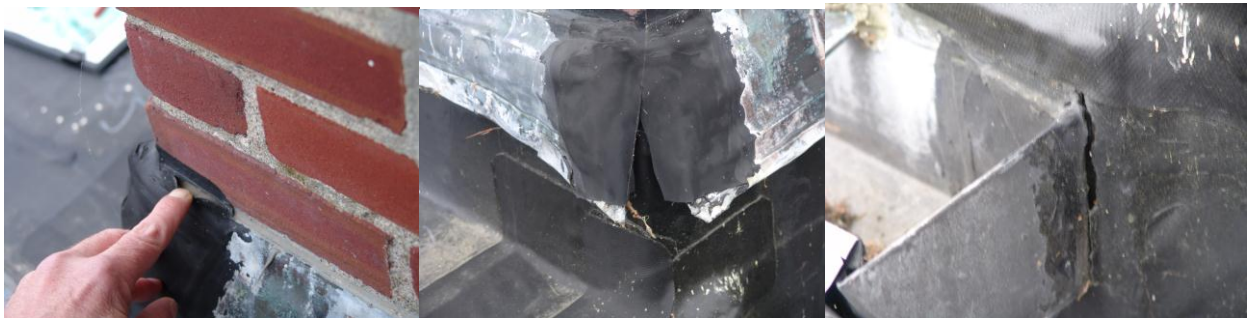
Observation No. 6

Slice/open corner seams at counter flashing and gutter, intermediate EPDM flat roof, coordinate D5.

Remove roofing cement/sealant. Seal edges with compatible sealant, set copper corner flashing cover in roofing cement/sealant.

Consider staged replacement of copper through-wall/counter flashing at original building details, during future roof replacement projects.

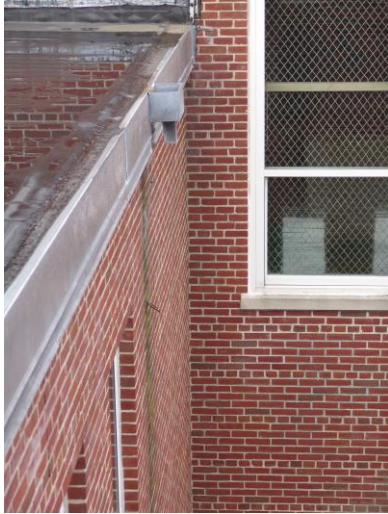
Observation No. 7

Missing downspout, intermediate EPDM flat roof, coordinate C4.

Clean debris, install new roof drain baskets. Consider metal baskets, properly fastened.

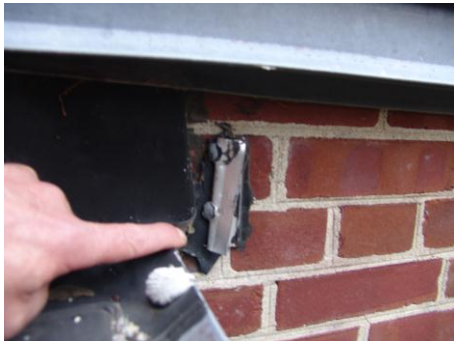
Observation No. 8

Missing termination bar, intermediate EDPM flat roof, coordinate B4.

Install termination bar set in water-cut-off mastic/compatible sealant.

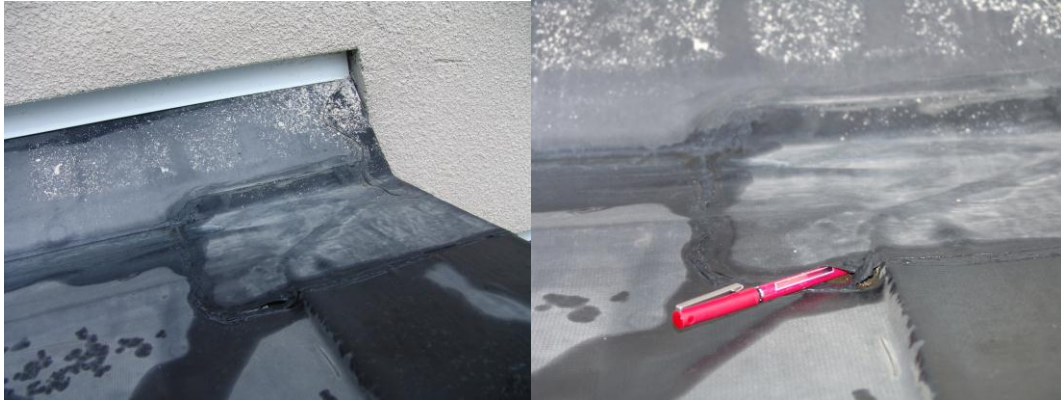
Observation No. 9

Delaminating flashing patch, intermediate EPDM flat roof, coordinate B4.

Clean, apply compatible seam sealant.

Apply EPDM patch.

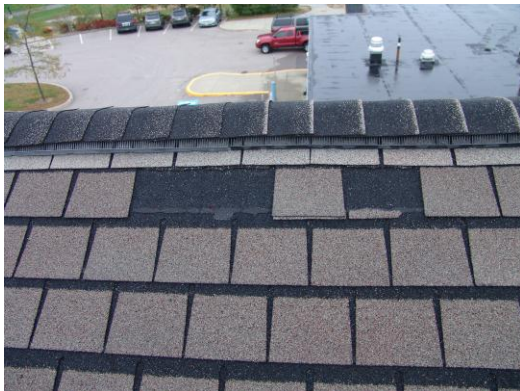
Observation No. 10

Missing shingles/tabs, intermediate asphalt shingle roof area, coordinate A4.

Replace damaged/missing shingles.

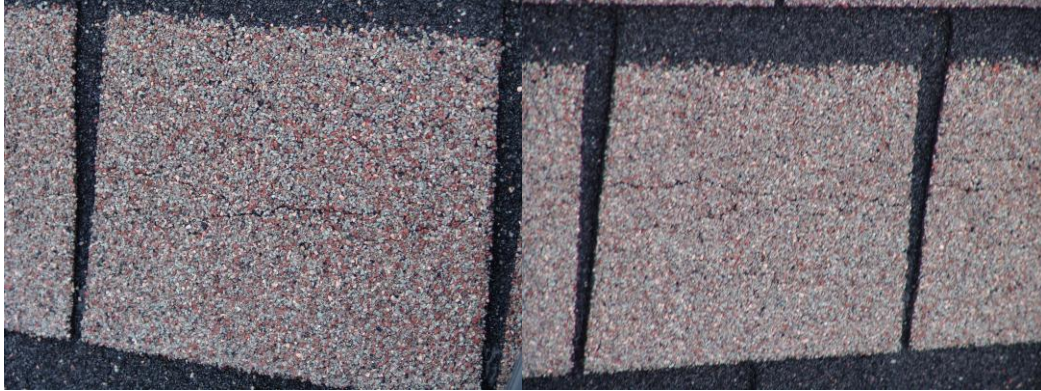
Observation No. 11

Cracking shingle tabs, typical through-out, intermediate asphalt shingle roof, coordinates A3-A5.

Inspect yearly for torn/missing shingles and leaks below.

Replace with 40 year shingles, minimum, at time of roof replacement.

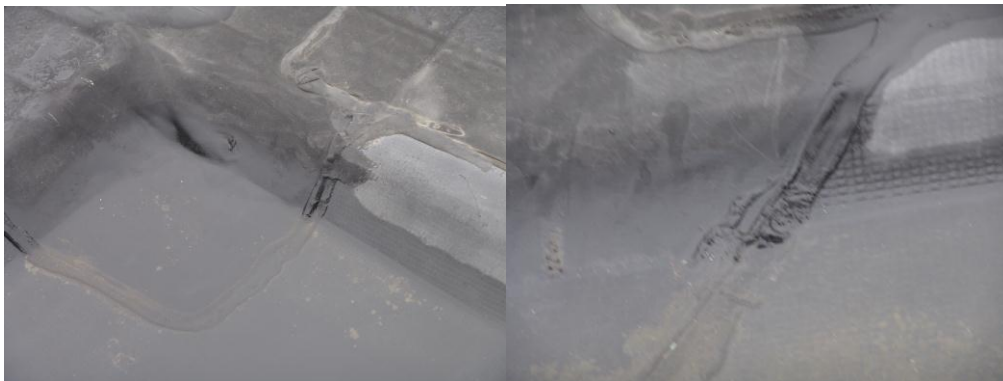
Observation No. 12

Failing seam sealant, delaminating corner flashing, ponding water, main EPDM flat roof area, coordinates B6, B7.

Clean, apply EPDM patches.

Coordinate installation of crickets/tapered insulation (to drain water to roof drains) at time of future roof replacement.

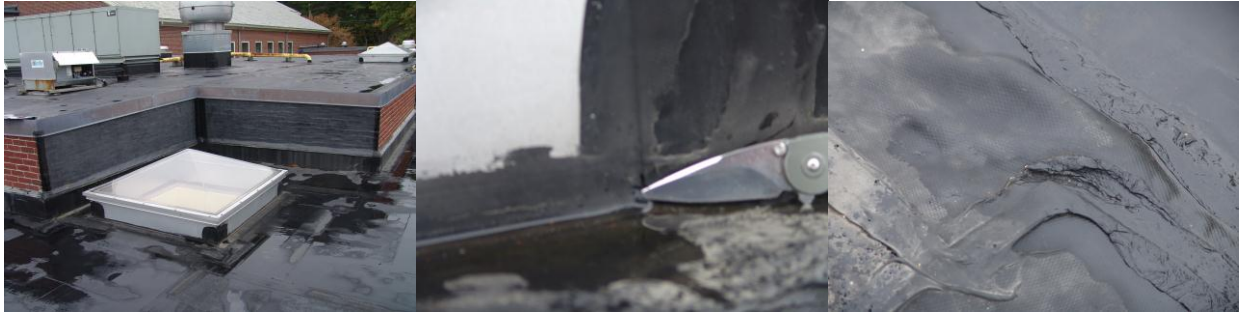
Observation No. 13

Open seam/puncture North-East corner flashing at skylight, failing seam sealant, delaminating corner flashing, reported leaks, stains at wood blocking, main EPDM flat roof area, coordinate B7.

Clean, apply EPDM patches.

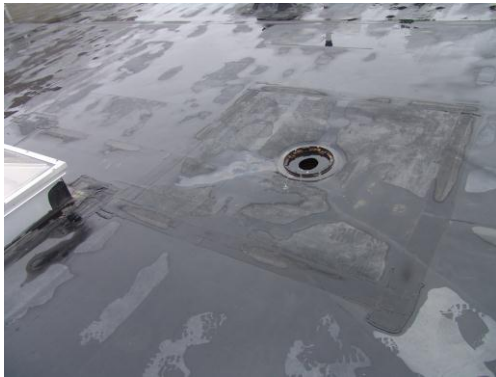
Observation No. 14

Failing seam sealant, delaminating cracked seam at flashing, main EPDM flat roof area, coordinates C10.

Install roof drain strainer/basket.

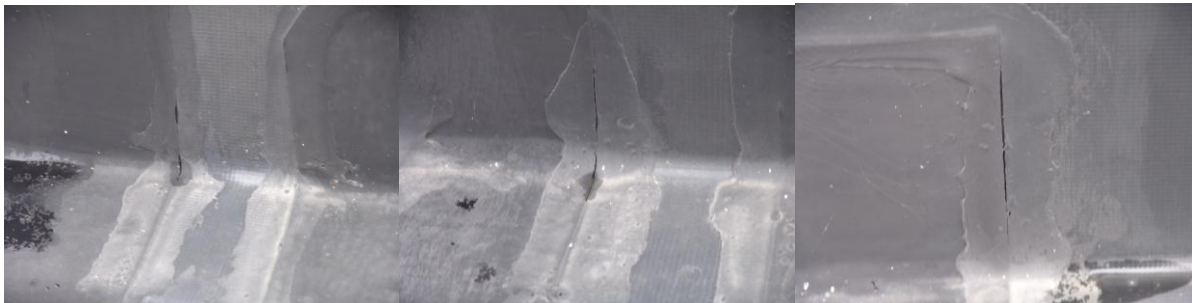
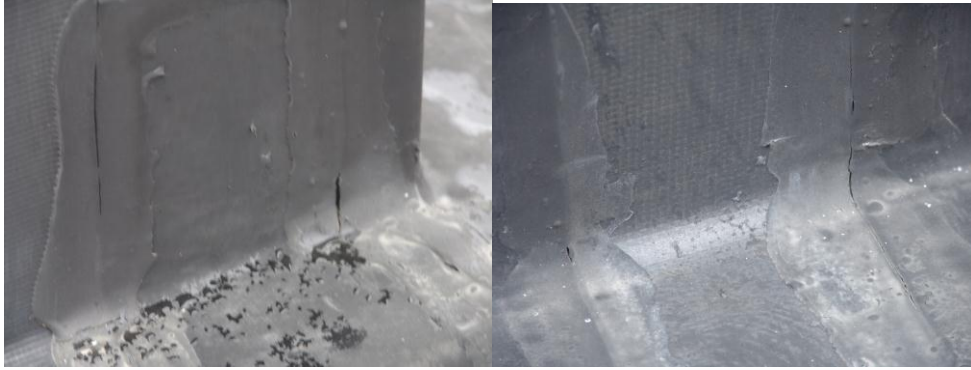
Observation No. 15

Failing splice seam sealant, delaminating cracked seams at flashing at EF-6, RI-1,EF-7,EF-8, main EPDM flat roof area, coordinates C8, B9, D9, C10.

Clean, apply compatible seam sealant.

Clean, apply EPDM patches.

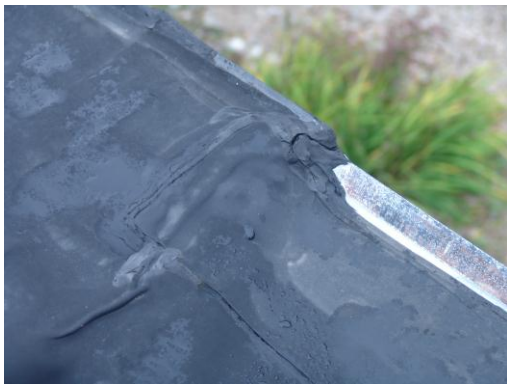
Observation No. 16

Open crack at expansion joint roof edge, main EPDM flat roof area, coordinate E9.

Apply compatible sealant.

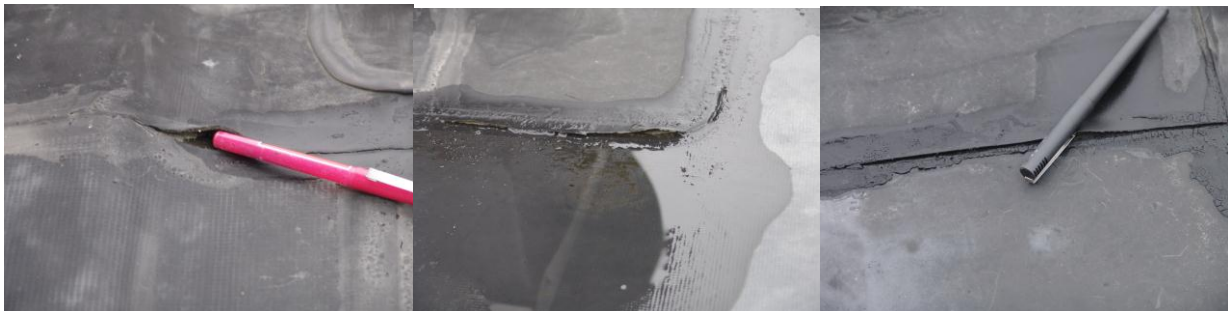
Observation No. 17

Failing seam sealant, delaminating corner flashing/patches, approx. 100 LF +/-, main EPDM flat roof area, coordinates E10,E11- L10,L11.

Clean, apply compatible sealant.

Clean, apply EPDM patches.

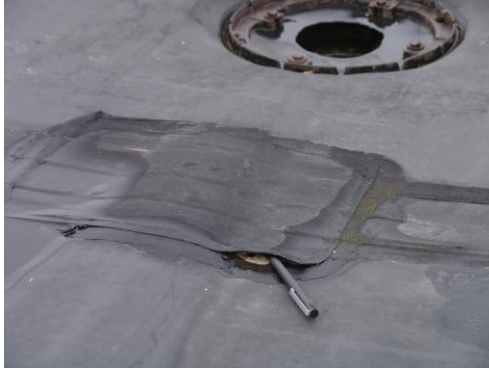
Observation No. 18

Delaminating EPDM patch, missing roof drain strainer/basket, main EPDM flat roof area, coordinate F11.

Clean, apply compatible sealant. Install roof drain basket.

Clean, apply EPDM patch.

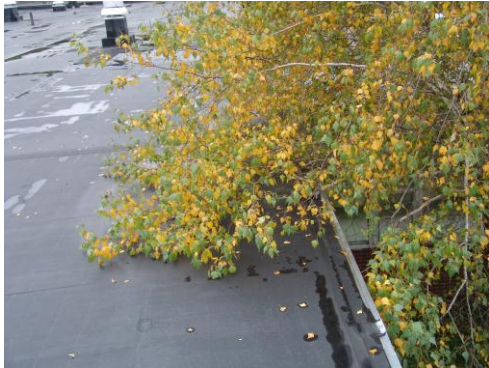
Observation No. 19

Tree branches encroaching on roof, main EPDM flat roof area, coordinate G9.

Prune/trim tree branches.

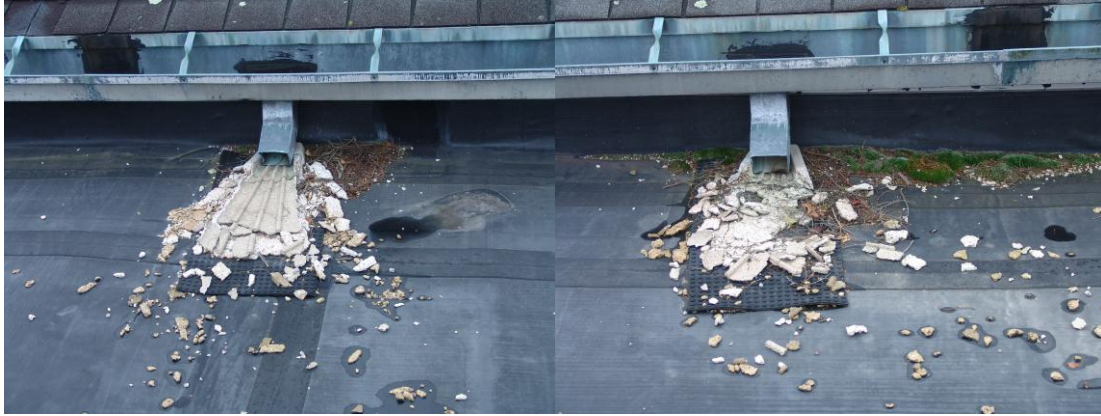
Observation No. 20

Disintegrated splash blocks, main EPDM flat roof area, coordinates L10, L11.

Remove debris and replace splash blocks.

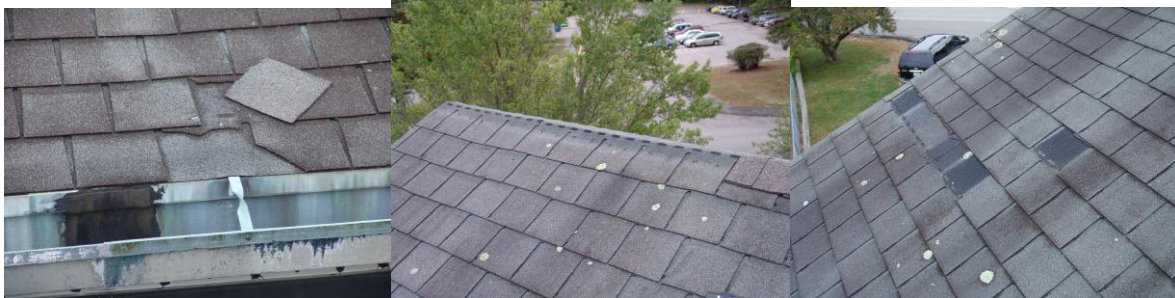
Observation No. 21

Missing/damaged asphalt shingles and cap shingles, South sloped asphalt shingle roof area, coordinates L11, M12.

Replace damaged/missing shingles.

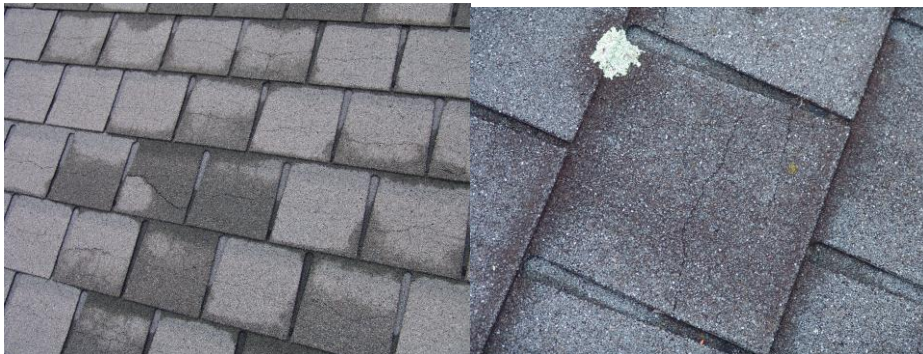
Observation No. 22

Cracking shingle tabs, typical through-out, intermediate asphalt shingle roof, coordinates N9-N12, M9-M12.

Inspect yearly for torn/missing shingles and leaks below.

Replace with 40 year shingles, minimum, at time of roof replacement.

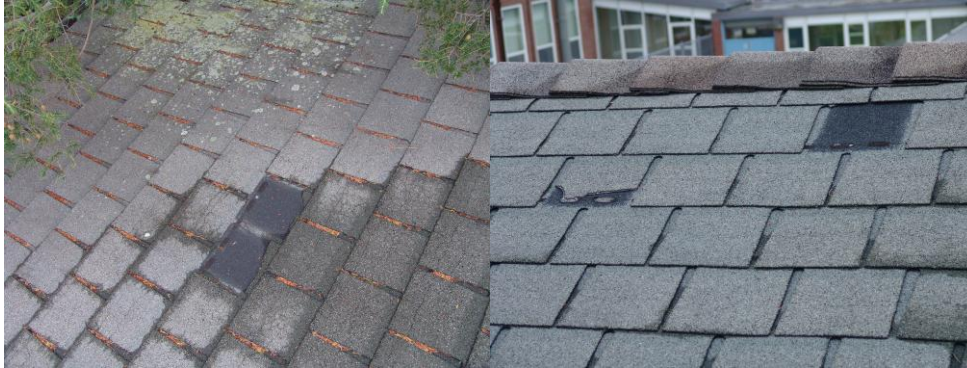
Observation No. 23

Missing/damaged asphalt shingles and cap shingles, South sloped asphalt shingle roof area, coordinate N9.

Replace damaged/missing shingles.

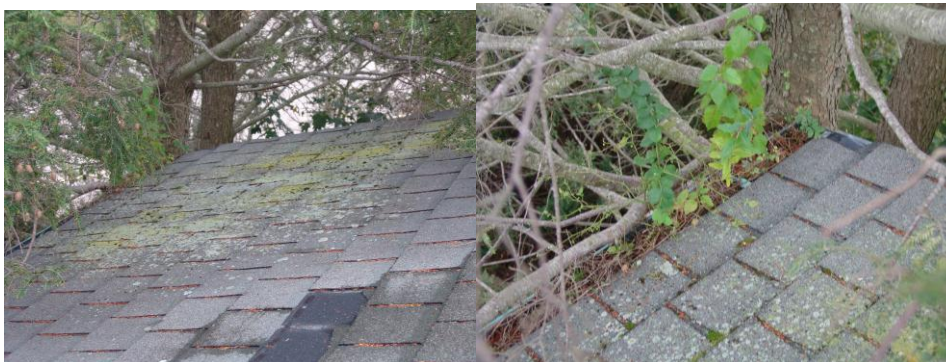
Observation No. 24

Tree branches encroaching on roof, organic matter/fungus growing on shingles, debris in gutter, south sloped asphalt shingle roof area, coordinate N9.

Clean, shingles of organic matter/fungus and apply fungicide.

Remove/prune tree.

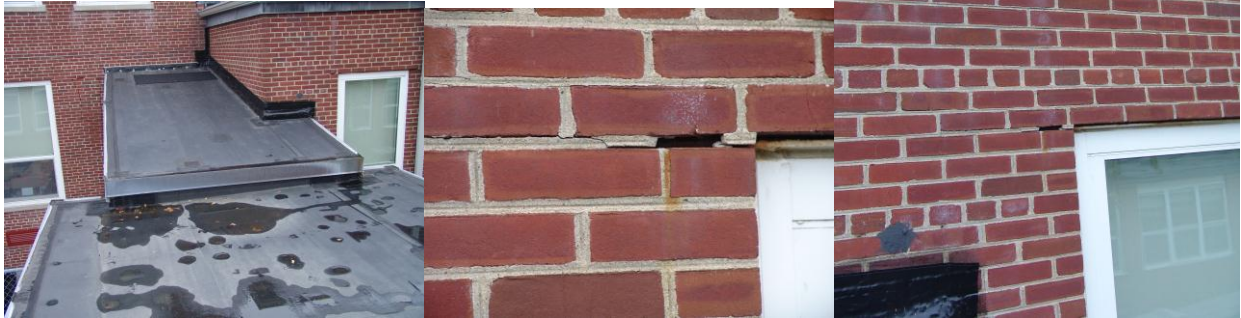
Observation No. 25

Leaks roof repairs this area, no apparent roof issues; mortar deterioration is suspect, main EPDM flat roof area, coordinate G7. Window head steel lintels rusting.

Survey lintel condition/integrity, treat or replace as required and repoint masonry.

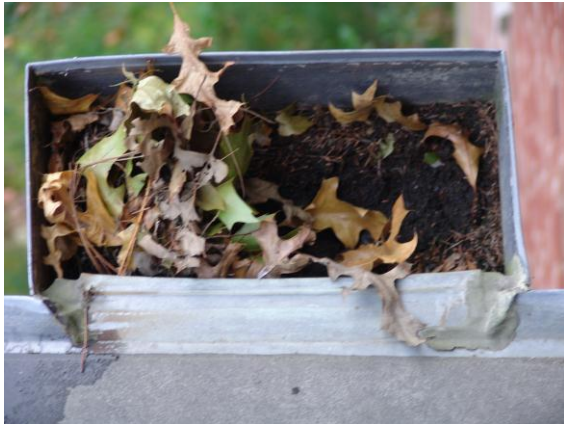
Observation No. 26

Debris, clogged scupper and downspout, lower EPDM flat roof area, coordinate C2.

Clean; remove debris at scupper and downspout.

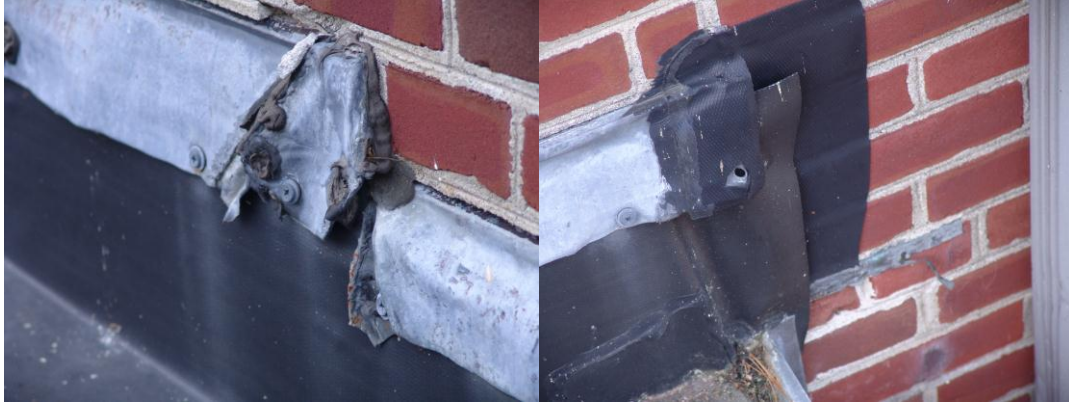
Observation No. 27

Poor counter flashing, missing termination bar, lower EPDM flat roof area, coordinate C1.

Install termination bar set in water-cut-off mastic/compatible sealant.

Inventory locations and consider systematic replacement of counter flashing during future roof replacement projects.

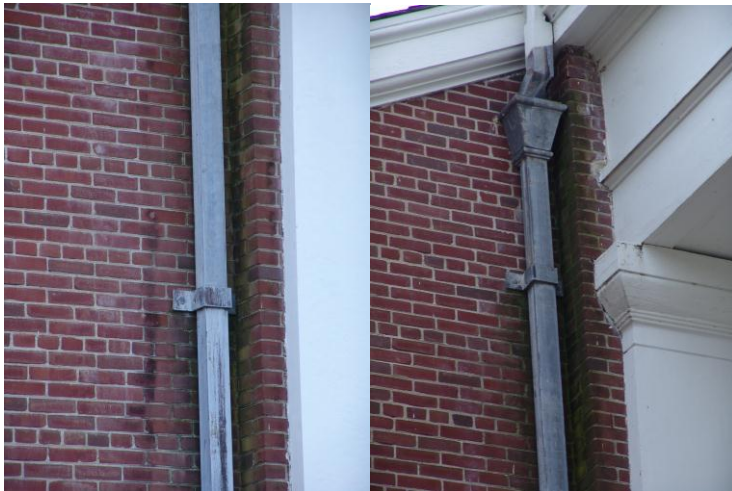
Observation No. 28

Malfunctioning downspout system, prolonged water damage at masonry, front entry, coordinate D1.

Inspect and clean gutter and downspout.

Clean masonry, repoint as required.

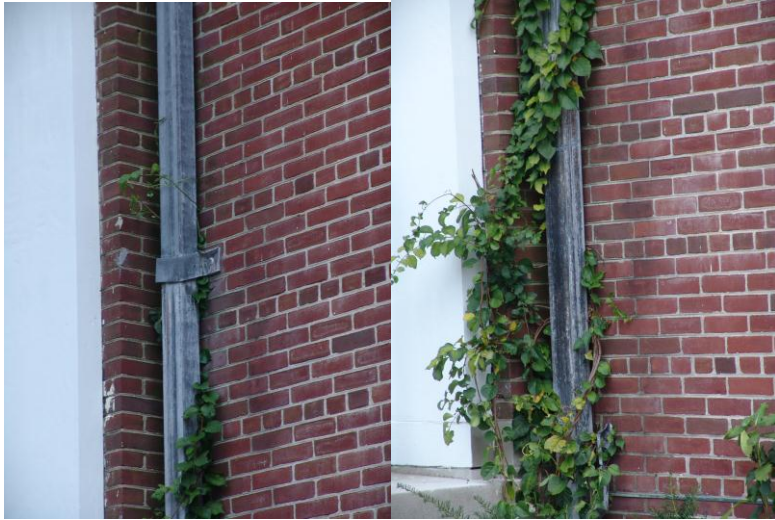
Observation No. 29

Previous water staining at masonry/ downspout system, plant growth at lower section, front entry, coordinate F1.

Inspect and clean gutter and downspout, remove plant/vine growth.

Inspect yearly.

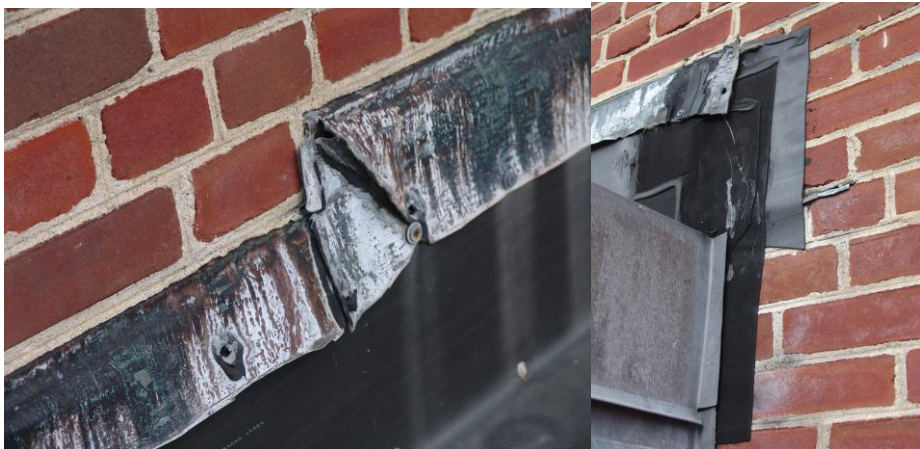
Observation No. 30

Poor counter flashing, missing termination bar, lower EPDM flat roof area, coordinates G1, G2.

Install termination bar set in water-cut-off mastic/compatible sealant.

Inventory locations and consider systematic replacement of counter flashing during future roof replacement projects.

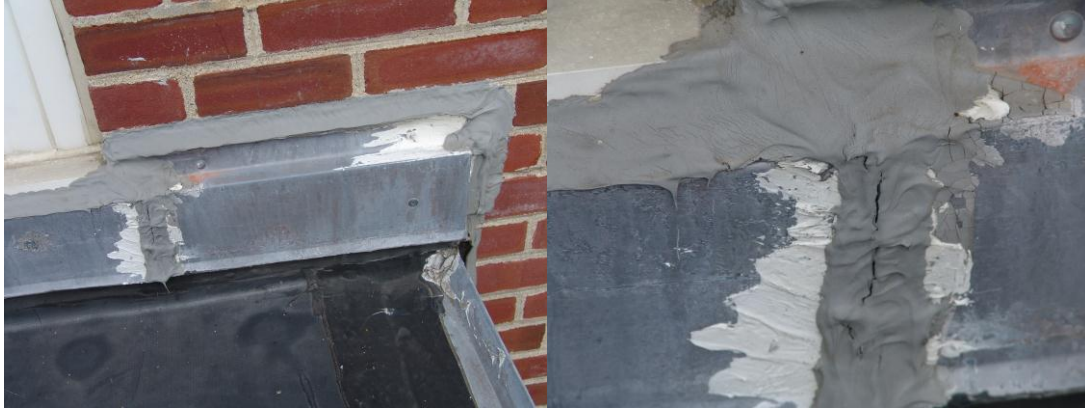
Observation No. 31

Poor counter flashing, excessive sealant, possible previous leaks, lower EPDM flat roof area, coordinates G2 G3.

Remove and reapply sealant at cracks/gaps.

Inventory locations and consider systematic replacement of counter flashing during future roof replacement projects.

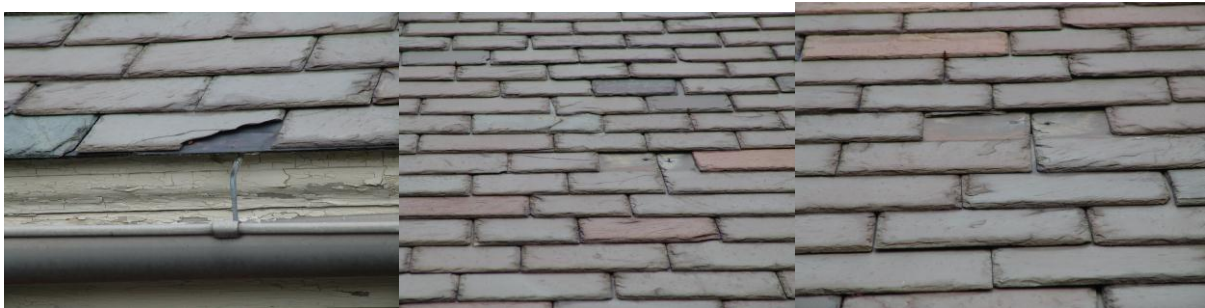
Observation No. 32

The High School Building has a number of items that require attention and/or ongoing monitoring. The majority of recommendations in this report involve repairs to improve long term serviceability. While there are no leaks reported at the slate roof area over the main entry, fasteners have deteriorated beyond their useful life, evident by falling slate shingles. The perimeter areas directly below the slate has been cordoned off to prohibit access to areas subjected to falling debris/slate. For safety reason, replacement of slate roofing is needed ASAP. Facilities are in the process of contracting for roofing replacement of this area.

Broken/missing slate shingles, fasteners have deteriorated beyond their useful life, evident by falling slate shingles below, slate roof area, coordinate F2.

Continue to maintain barricade below for safety, replace roofing with 40 year plus asphalt or composite/slate shingles.

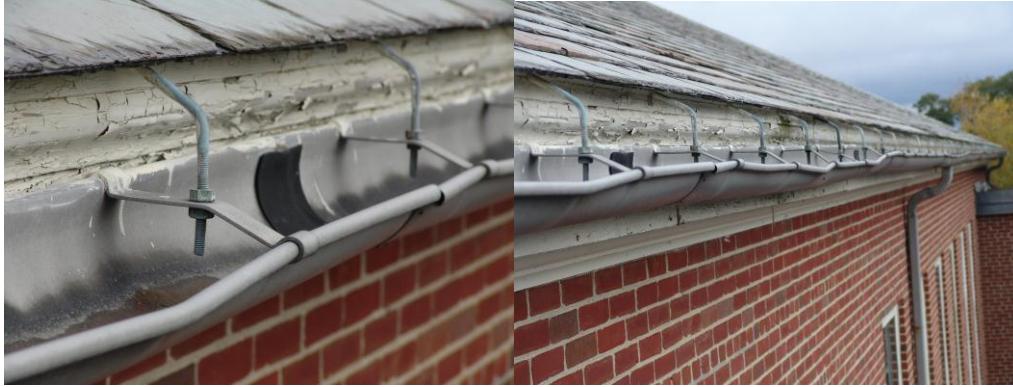
Observation No. 33

Opening gaps at deteriorating gutter, previous patches, slate roof area, coordinate G2, G3. Typical condition.

Survey and apply patches/gutter seal.

Consider replacement or refurbishment at time of roof replacement.
