ROOF ASSESSMENT REPORT

WHITMAN HANSON REGIONAL HIGH SCHOOL

NOVEMBER 08, 2010

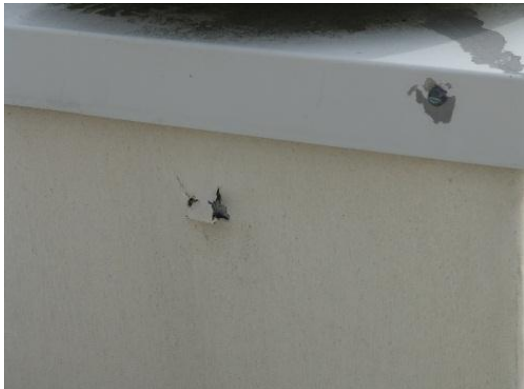
Observation No. 1

Tear in PVC curb at Roof Top intake 100, lower PVC flat roof, coordinate E3.

Apply compatible roofing cement/sealant.

Install appropriate PVC patch.

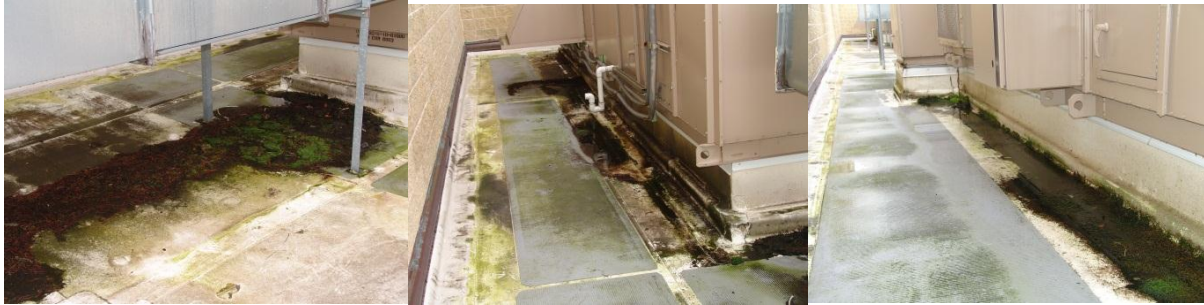
Observation No. 2

Debris and organic growth at RTU-9 and RTU-10, lower PVC flat roof, coordinates H3-H6.

Remove debris and organic growth, clean impacted roof areas.

Inspect problematic areas yearly; implement short term recommendations as necessary. Coordinate installation of crickets/tapered insulation (to drain water away from mechanical units) at time of future roof replacement.

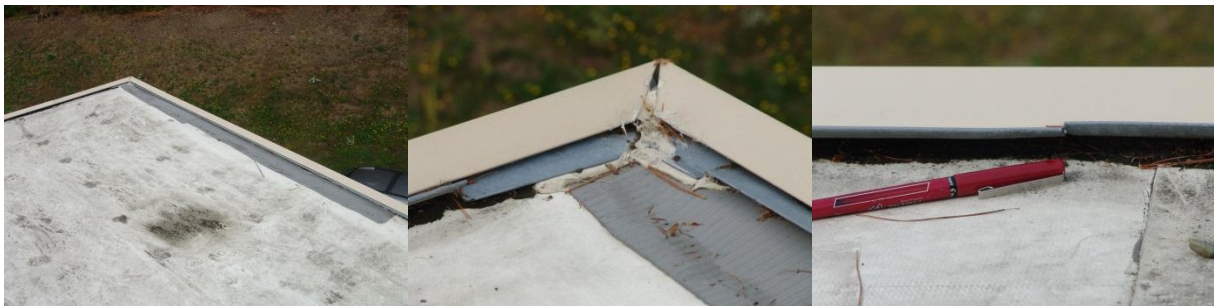
Observation No. 3

Suspect gravel stop/fascia and PVC roof edge terminations, intermediate PVC roof at coordinate A2. Past leaks at Kitchen below were reported, and evidence of repairs and attempts to address the problem. Leaks likely due to poor termination of PVC roof edges, lifting gravel stop spring clips and open corner seams at aluminum fascia.

Watch for future leaks at ceiling below (currently not reported as leaking).

Remove fascia/gravel stop assemblies; investigate PVC roof terminations in this area and institute

corrective action if/when leaks reappear or at time of future roof replacement. Review PVC termination and gravel stop/spring clip detail for compliance with manufacturer's recommendations.

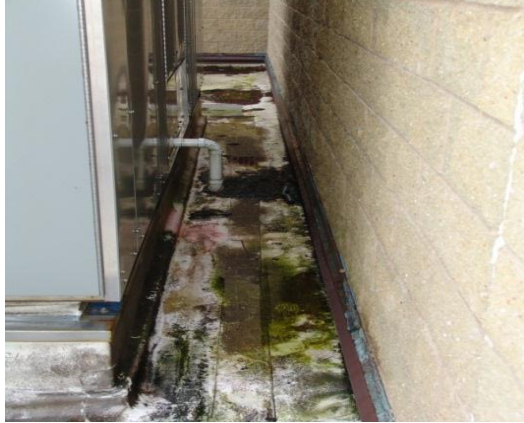
Observation No. 4

Debris and organic growth at mechanical unit, intermediate PVC flat roof, coordinate A9.

Remove debris and organic growth, clean impacted roof area.

Inspect yearly for evidence of leaks; Coordinate installation pre-formed copper corner flashing at time of future roof replacement.

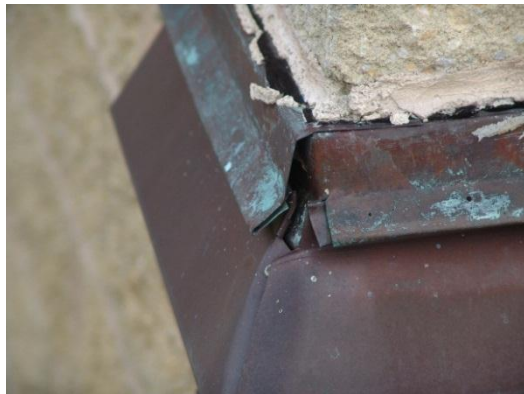
Observation No. 5

Open corner at copper roof-to-wall counter flashing, intermediate PVC flat roof, coordinate A10.

Install backer rod and compatible sealant, inspect yearly.

Install pre-formed copper corner cover.

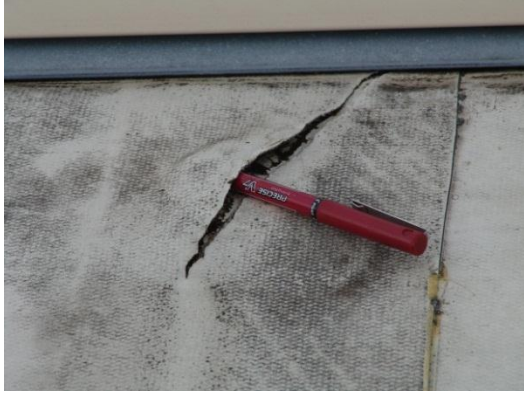
Observation No. 6

Tear and delamination at PVC lap seam, intermediate upper PVC flat roof, coordinate F7.

Clean and apply compatible roofing cement/sealant.

Apply PVC patch.

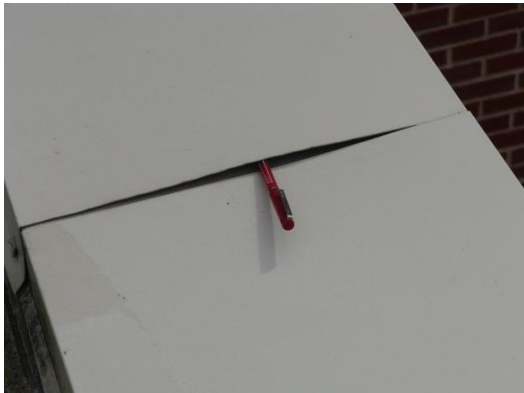
Observation No. 7

Open butt joint at parapet cap flashing, intermediate upper PVC flat roof, coordinate H9.

Install 4” wide aluminum cap flashing expansion strip. Set in water-cut-off mastic/fasten to one side.

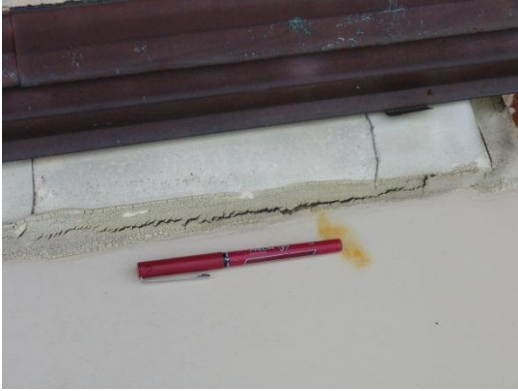
Observation No. 8

Cracked/deteriorated sealant @ parapet, upper PVC flat roof, coordinate H10.

Remove old sealant, clean and apply compatible roofing cement/sealant.

Inspect areas with similar detail/condition for evidence of sealant failure and implement short term recommendation.

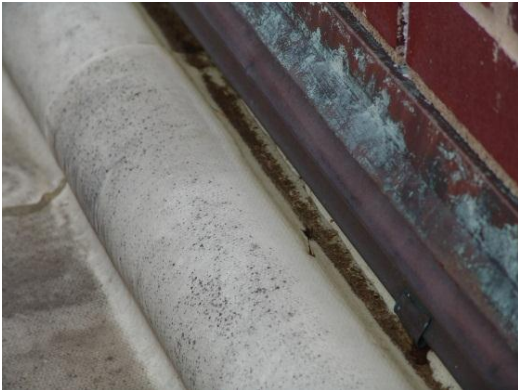
Observation No. 9

Water pocket at roof-to-wall expansion joint assembly, intermediate upper PVC flat roof, coordinates I7-I9.

Inspect yearly for evidence of leaks below or material failure.

Coordinate installation of alternate expansion joint profile (that allows water to drain away from wall flashing) at the time of future roof replacement.

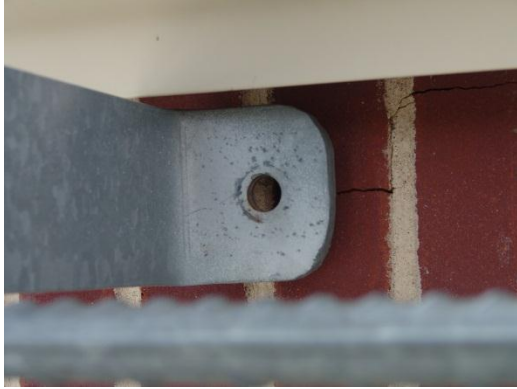
Observation No. 10

Missing roof ladder bolt and cracked brick veneer, high, intermediate PVC flat roof, coordinate C6.

Seal brick crack, install epoxy anchor bolt.

Inspect ladder fasteners yearly.

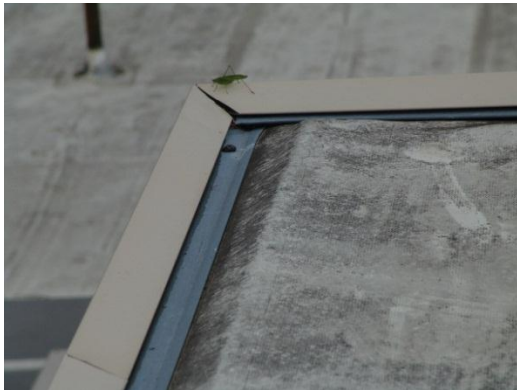
Observation No. 11

High insulation at gravel stop/PVC roof termination, high intermediate PVC flat roof area allowing water to sit/pocket at edge, coordinate A10.

Inspect yearly for evidence of leaks below.

Coordinate modification of tapered insulation/protection board to drain water to internal roof drains at the time of future roof replacement.

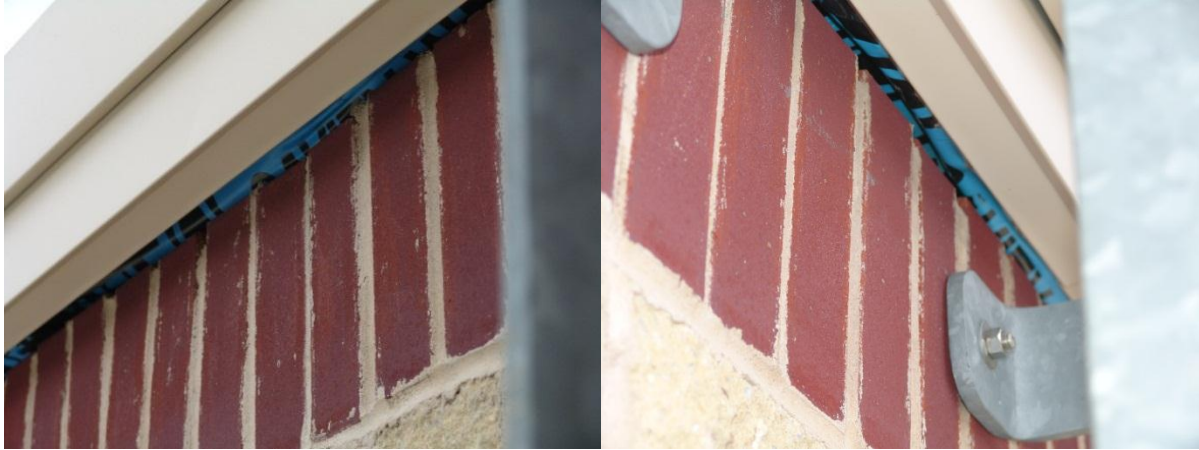
Observation No. 12

Gap at fascia to brick veneer transition above high intermediate PVC flat roof, coordinate D10. Air/Vapor Barrier is exposed to varying degrees through-out.

Inspect yearly for evidence of leaks below and/or material deterioration.

Coordinate modification of fascia depth and/or profile to reduce gap at transition at the time of future roof replacement.

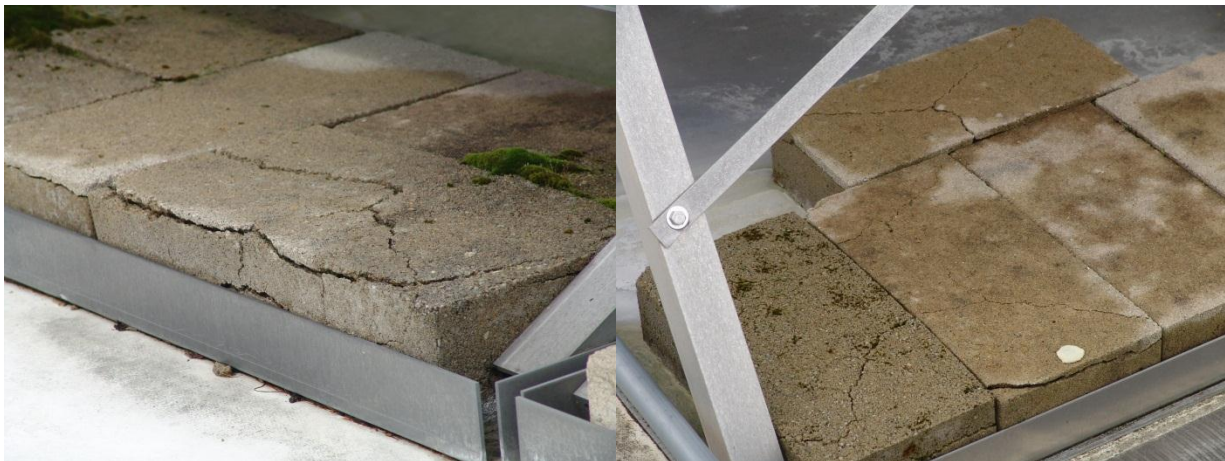
Observation No. 13

Crumbling CMU ballast @ PV support system, high intermediate PVC flat, coordinate A10.

Approximately 35% significantly damaged possible property and/or personal damage from wind-blown CMU pieces.

Trap/cover immediately. Remove all cracked/damaged CMU, replace with alternate ballast material- minimal absorption- resistant to freeze/thaw cycles. Confirm weight and distribution design requirements for PV system and roof structure limitations.

Coordinate replacement of PV ballast system in its entirety- refer to short term recommendations. 270 sleds with (12) - 4x8x16 solid CMU blocks each.

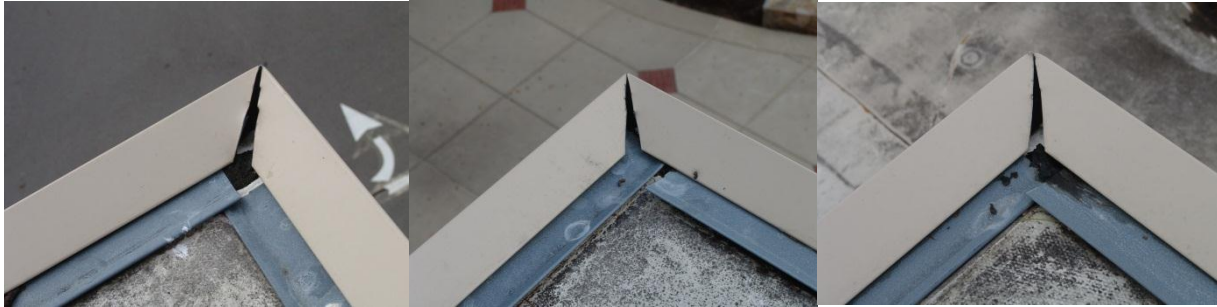
Observation No. 14

Gap at alum. fascia/gravel stop, outside corners, high intermediate PVC flat roof, coordinate M9. Extent of void/gap at corners vary through-out entire roof. Largely a cosmetic issue depending on the integrity/workmanship of PVC corner and edge terminations below/adjacent to gap condition.

Inspect yearly for evidence of leaks below and/or material deterioration.

Coordinate modification of fascia/installation of alum. cover strip or preformed outside corner at the time of future roof replacement.

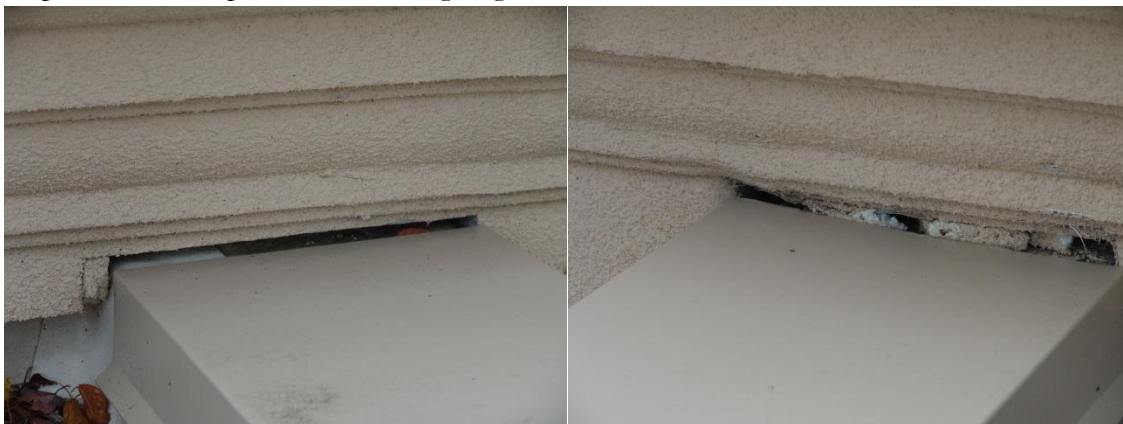
Observation No. 15

Gap at alum. Parapet to EIFS siding, high intermediate PVC flat roof, coordinates M1, M9.

Clean debris; install backer-rod and compatible sealant.

Inspect all sealant conditions as part of ongoing maintenance at regular intervals.

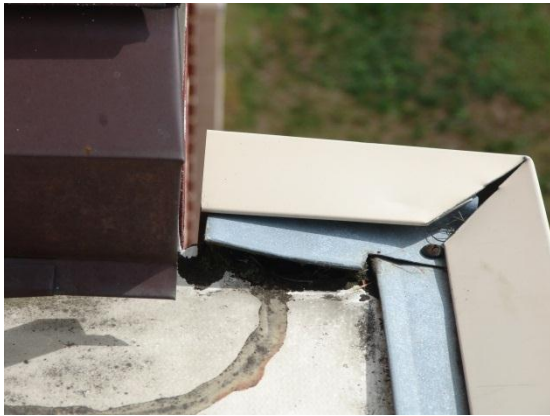
Observation No. 16

Gap at alum. Fascia/gravel stop to brick veneer siding, parapet, high intermediate PVC flat roof, coordinate J10.

Inspect yearly for evidence of leaks below and/or material deterioration.

Clean debris; install backer-rod and compatible sealant.

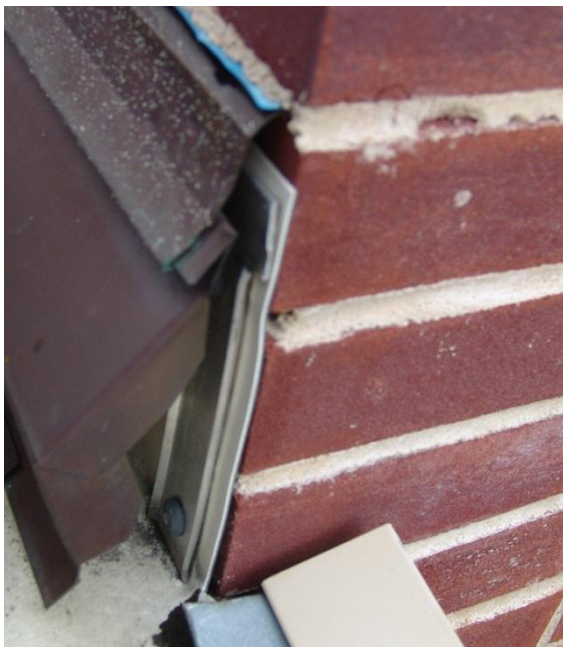
Observation No. 17

Improper terminations, missing copper counter-flashing corner termination, high intermediate PVC flat roof allowing water to sit/pocket at edge, coordinate J10.

Inspect yearly for evidence of leaks below.

Properly terminate PVC roof-to-wall condition. Set termination bar in water-cut-off mastic. Install proper copper counter-flashing termination wrapping corner.

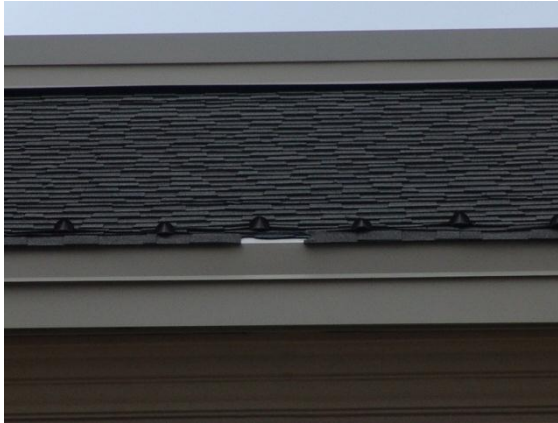
Observation No. 18

Damaged shingle @ roof edge, low asphalt shingle roof, coordinate N4.

Replace damaged shingle.

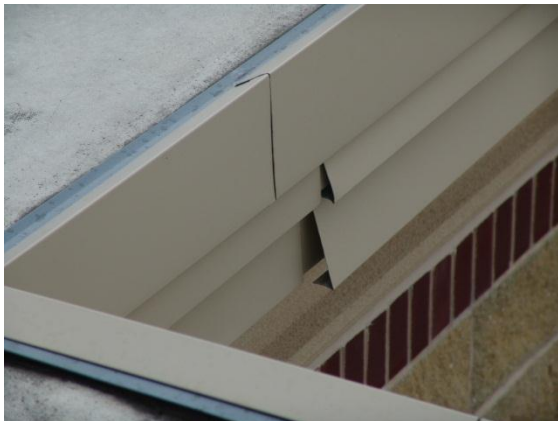
Observation No. 19

Lifted alum. Fascia @ courtyard, high PVC flat roof, coordinate G12.

Fasten with spring clip-allow slip joint for horiz. movement.

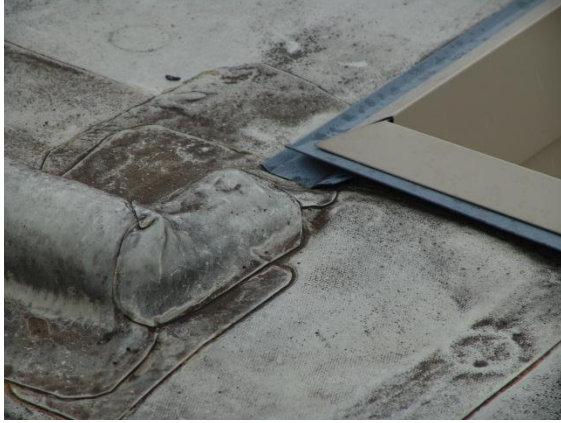
Observation No. 20

Lifted gravel stop spring clip, high PVC flat roof, coordinate G12.

Inspect yearly for evidence of leaks below.

Coordinate proper installation of gravel stop, spring clip and PVC roof edge termination at the time of future roof replacement. Refer to manufacturer's standard/recommended installation details.

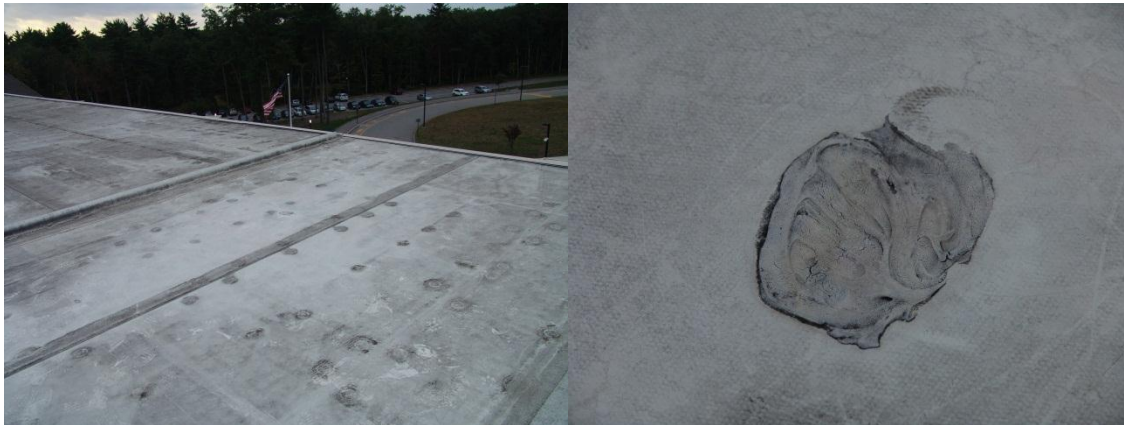
Observation No. 21

Spongy substrate, likely wet insulation/leaks reported @ Library below, high PVC flat roof, coordinates I14-J14. Possible water traveling to expansion joint, down to floor structure below, traveling to Library.

Inspect/confirm wet insulation after major rain event. Confirm water travel route at/along expansion joint. Patch/replace damaged materials and PVC roofing contingent on findings.

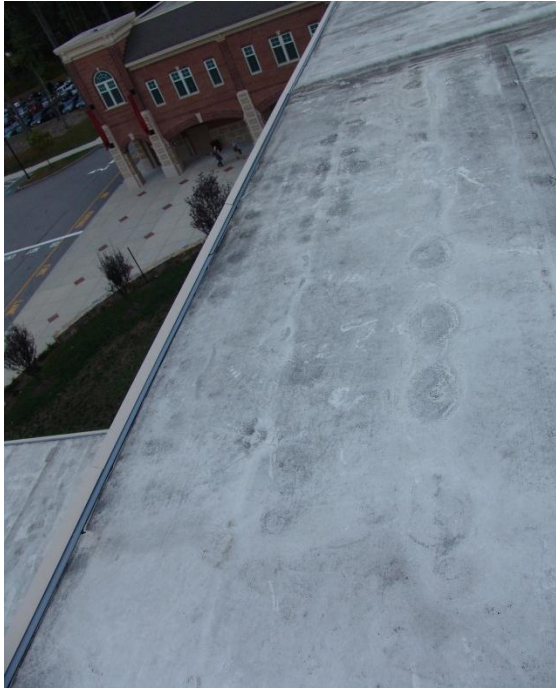
Observation No. 22

Loose/delaminated PVC roofing and poor termination, high PVC flat roof, coordinates J14-J19. Billowing PVC under strong wind conditions, PVC roofing terminations @ vertical fascia not

sealed/allowing wind and possible driven rain infiltration.

Remove/replace or re-adhere PVC roofing. Remove alum. Fascia and gravel stop assembly and seal/properly terminate PVC roofing edges (approx. 125 linear feet).

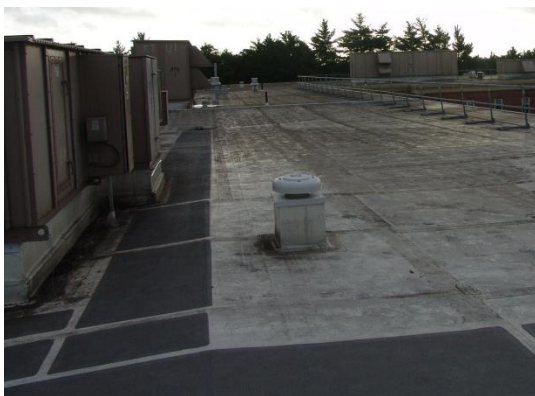
Observation No. 23

Evidence of water sitting against curbs of mechanical units, high PVC flat roof coordinates B11-B12.

Inspect yearly for evidence of leaks below.

Coordinate modification of tapered insulation/protection board to drain water to internal roof drains at the time of future roof replacement.

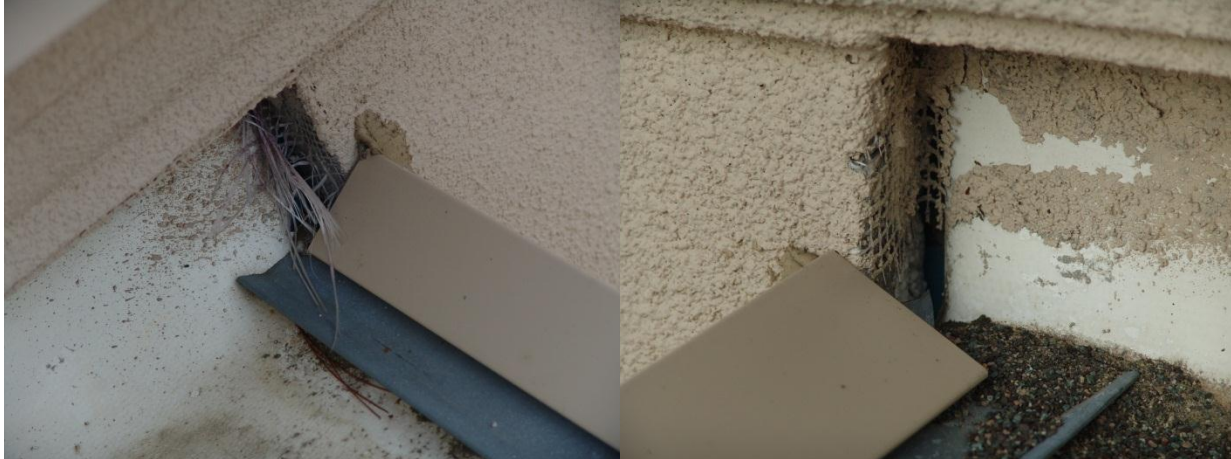
Observation No. 24

Voids at PVC roofing to EIFS wall siding at gravel stops/ roof termination, low intermediate PVC flat roof, coordinates K18 and K19.

Remove debris, patch EIFS, and install backer rod and sealant.

Inspect and replace sealants as part of periodic maintenance plan.
