# **ROOF ASSESSMENT REPORT**

**WHITMAN MIDDLE SCHOOL**

**NOVEMBER 08, 2010**

**WHITMAN HANSON REGIONAL SCHOOL DISTRICT**

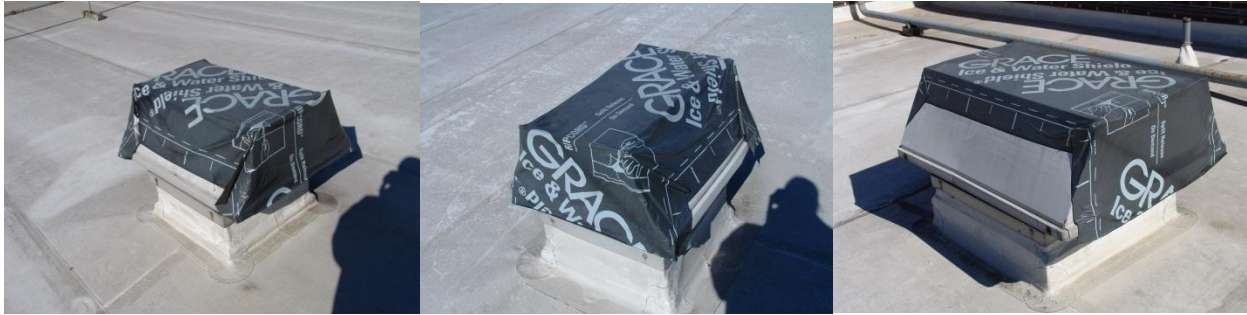
## **Observation No. 1**

Ice and water sheild wrap at roof vents, multiple locations, main PVC flat roof, coordinate E11, upper flat roof, coordinate B11,B10, lower flat roof, coordinate I6. Unknown reason for this

temporary measure.

Verify water infiltration issue, investigate further.

Replace vent units.

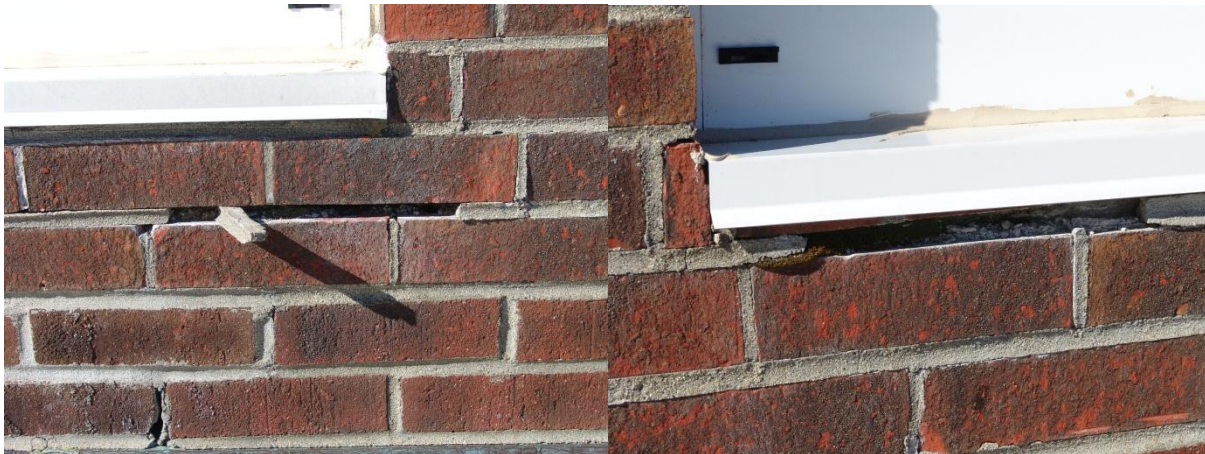
### **Observation No. 2**

Deteriorated, dry and missing mortar @ brick wall, main PVC flat roof, coordinates J10-N10. Leaks reported below. Alum. sill flashing at windows are lifting and sloped inward.

Re-point brick wall approx. 10'x 150'. Replace alum. window sill flashing.

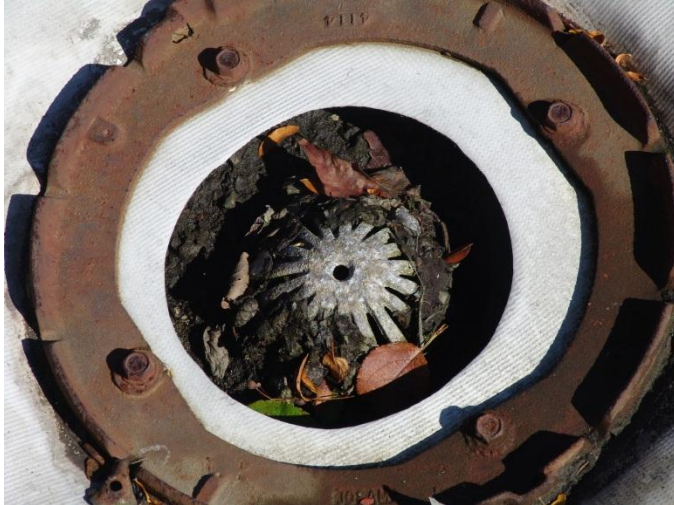
### **Observation No. 3**

Debris at roof drain strainer/basket, poor basket detail, main PVC roof, coordinate M10 (photo), typical 16 locations.

Remove debris and organic matter. Install upper basket.

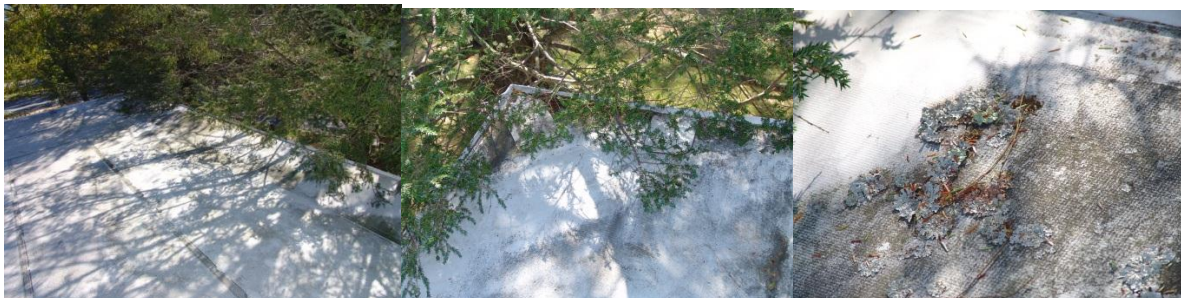
#### **Observation No. 5**

Tree branches at roof edge, organic growth on membrane, main PVC flat roof, coordinates N12, N13

Prune trees/bushes, two feet min. off roof edge, remove and clean organic growth.

Review every two years.

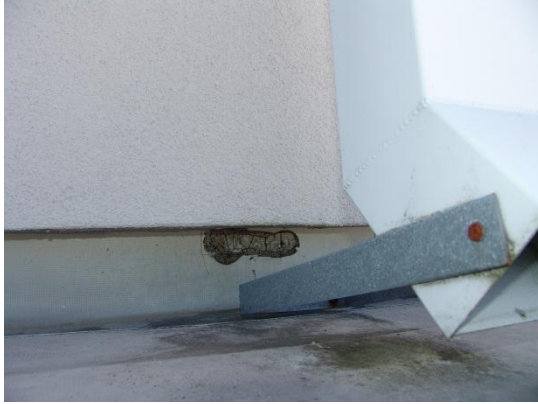
### **Observation No. 6**

Holes at PVC wall flashing, detached downspout bracket, main PVC flat roof, coordinate G14.

Clean and apply compatible roofing cement/sealant and re-fasten bracket.

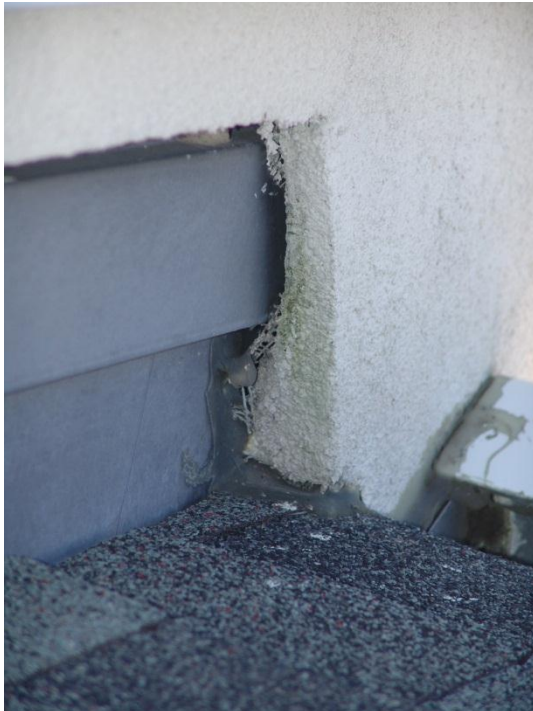
### **Observation No. 7**

Gap at EIFS transition/LCC roof-to-wall flashing, sloped asphalt shingle roof area, coordinate H15.

Clean debris; install backer-rod and compatible sealant.

Inspect all sealant conditions as part of ongoing maintenance at regular intervals.

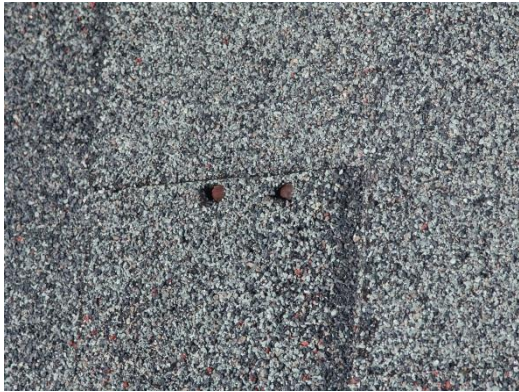
### **Observation No. 8**

Protruding fasteners, sloped asphalt roof area, coordinate H14.

Remove fasteners, install new fasteners, apply compatible roofing cement/sealant.

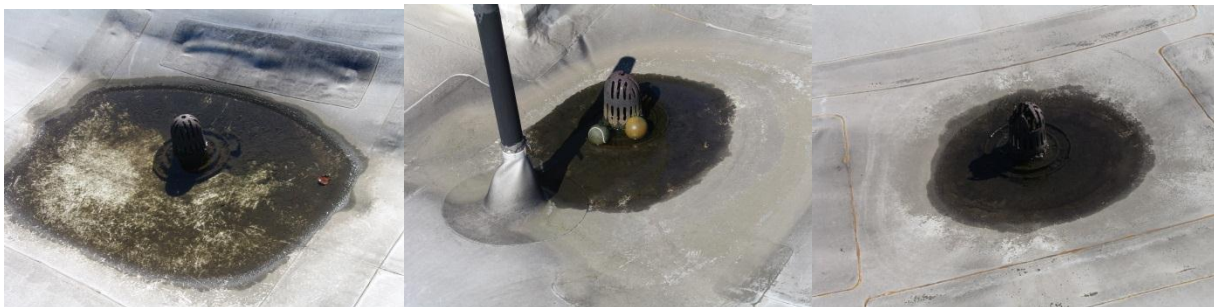
### **Observation No. 9**

Ponding water at roof drains due to strainer/basket detail, upper PVC flat roof, coordinates G6, B10, B8, B2.

Remove and replace basket, clean debris/organic matter- included in Observation #3.

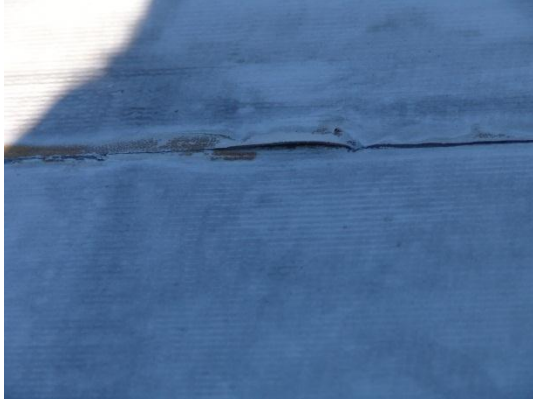
### **Observation No. 10**

Lifting/delaminating lap seam, upper PVC flat roof, coordinates D8.

Clean and apply compatible lap sealant.

Install appropriate PVC patch.

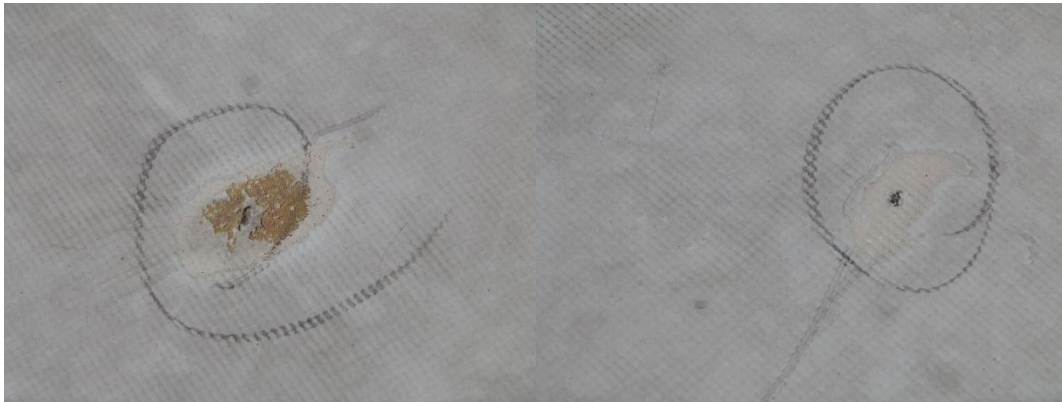
**Observation No. 11**

Tear in PVC membrane, upper PVC flat roof, coordinates C8, B13.

Replace protruding fastener, clean and apply compatible roofing cement/sealant.

Install appropriate PVC patch.

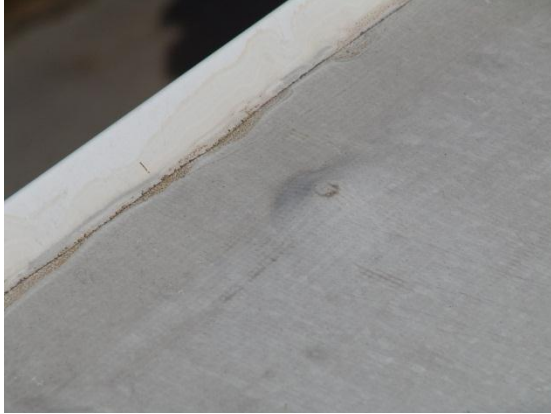
**Observation No. 12**

Protruding fastener, upper PVC flat roof, coordinate A13.

Inspect problematic areas yearly; watch for future leaks at ceilings below (currently not reported as leaking) limit foot traffic.

Remove protruding fasteners, replace with new fasteners/washers and assure proper bight/holding into deck/substrate below.

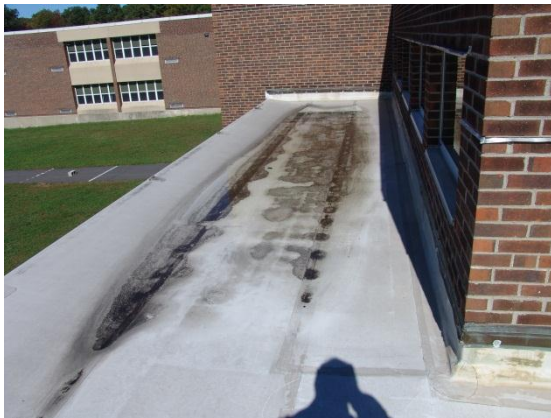
### **Observation No. 13**

Ponding water, lower PVC flat, coordinate H5.

Inspect area yearly; verify no leaks are evident below.

Inspect problematic areas yearly; implement short term recommendations as necessary. Coordinate installation of crickets/tapered insulation (to drain water to roof drains) at time of future roof replacement.

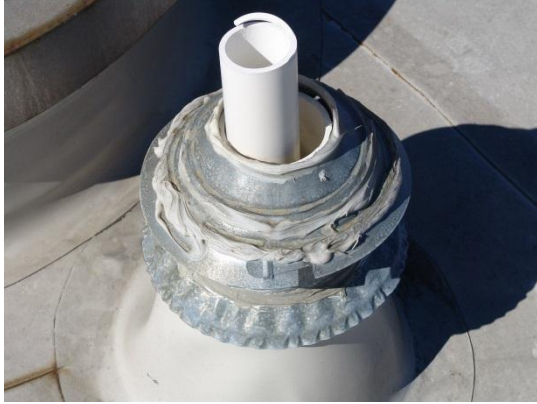
### **Observation No. 14**

HWH intake/vent penetration, lower PVC flat roof, coordinate L6.

Inspect yearly for evidence of leaks below and/or material deterioration.

Replace with standard penetration detail.

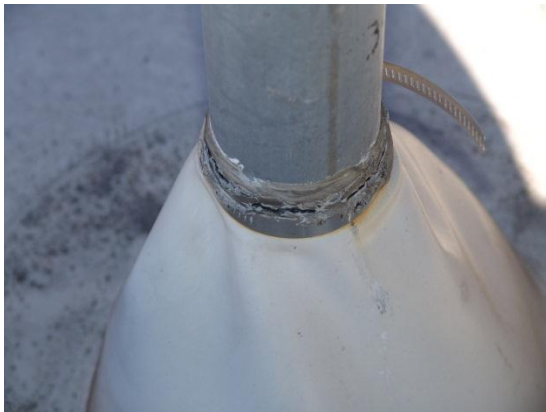
**Observation No. 15**

Deteriorated sealant at penetration boot ring clamp, main PVC roof, coordinate I7.

Remove ring clamp, remove sealant, clean and apply compatible sealant.

Inspect details with sealant yearly and replace as part of ongoing maintenance plan.
